Shoreland Assessments and Critical Habitat Mapping of Alma and Moon Lakes, Vilas County, Wisconsin

Mike Meyer and Jim Kreitlow
NOVA Ecological Services
Boulder Junction, WI 54512
(novaecologicalservies@outlook.com)

June 18, 2024

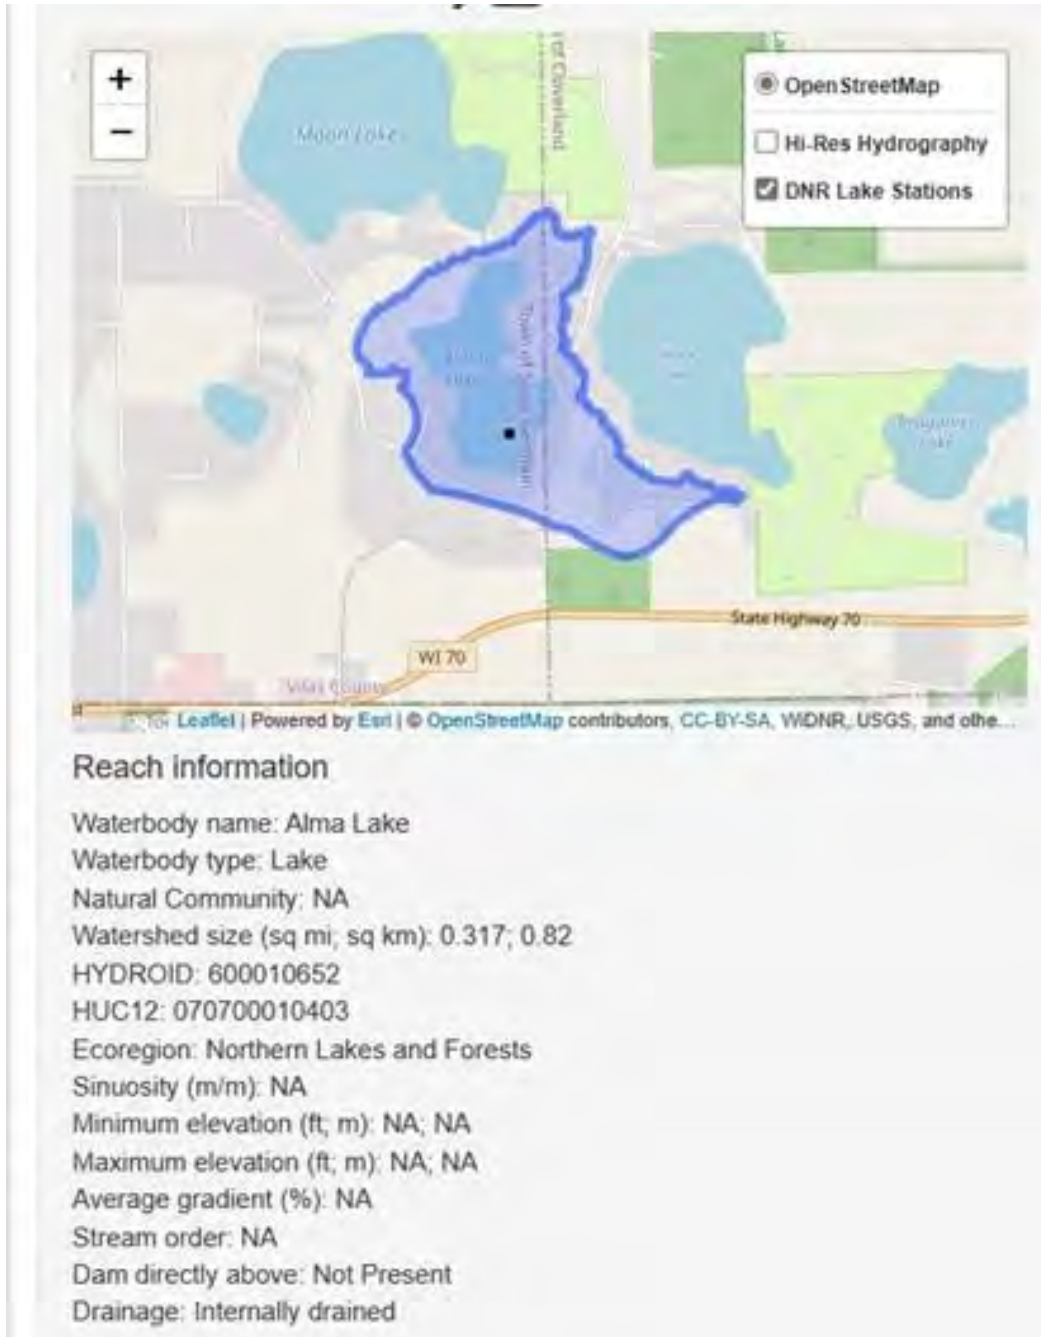
Figure 3. Land Area Draining to Alma Lake. Alma Lake was assessed by the WDNR and is not considered impaired under Wisconsin’s Consolidated Assessment and Listing Methodology (WisCALM) and meets water quality standards. The lake supports a warmwater fishery and is managed for panfish, musky, largemouth bass, smallmouth bass, and walleye. All of Alma Lake shoreline is in private ownership.

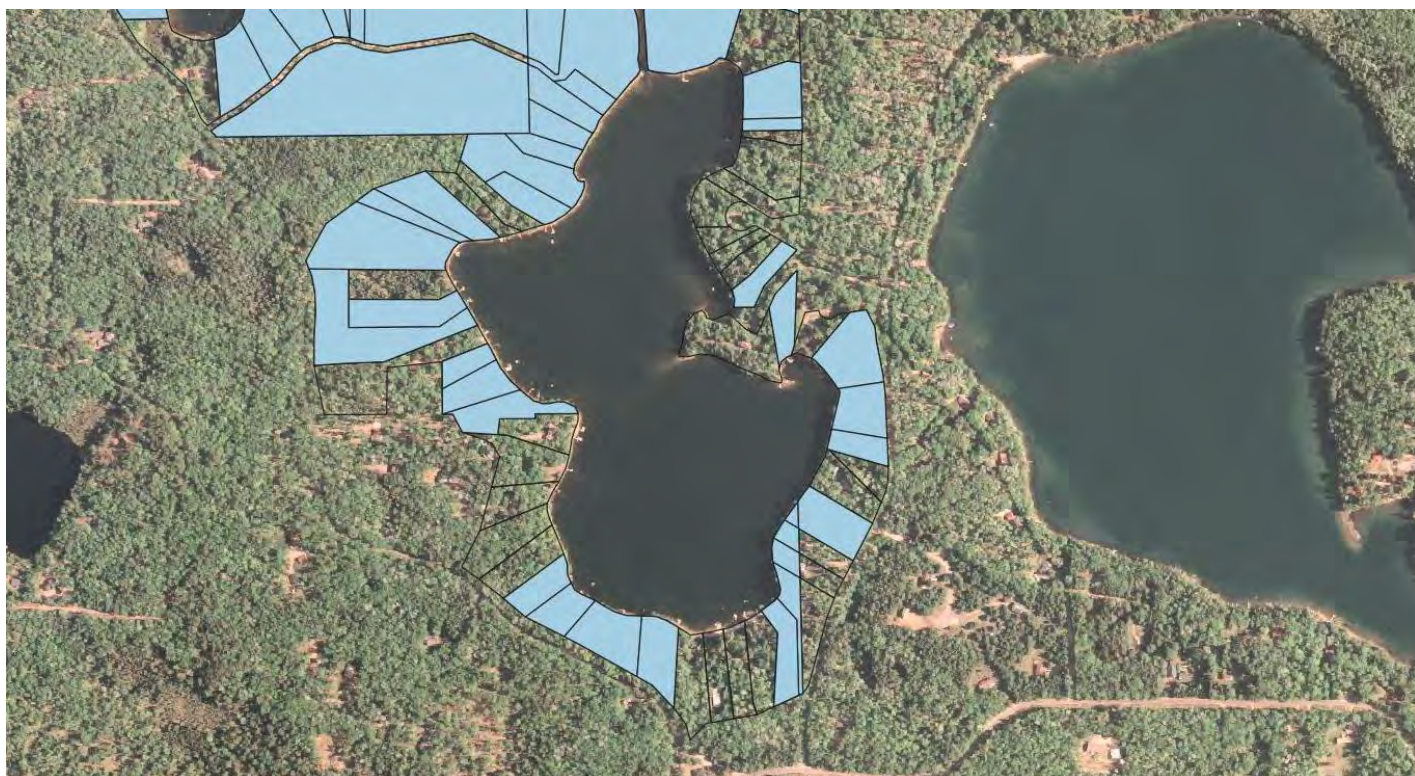
Figure 4. Alma Lake tax parcels shaded in blue have shoreland with greater than 60% of the buffer area in native trees, shrubs, forbs, and grasses.

Shoreland development often degrades the habitat quality of lakeshore buffer zones. In this study, we define the buffer zone to be from the ordinary high-water mark (OHWM) to 35' inland. Manicured lawns reduce wildlife habitat, and impervious surfaces (rooftops, driveways, patios, etc.) increase nutrient and sediment run-off. Lake managers recommend leaving at least 70% of the buffer in native vegetation. As stated in Wisconsin Shoreland Zoning Minimum Standards ([Wisconsin's Shoreland Management Program | Wisconsin DNR](#) NR115.05(3)(c), Wis. Admin. Code): **“The county may allow removal of trees and shrubs in the vegetative buffer zone to create access and viewing corridors, provided that the combined width of all access and viewing corridors on a riparian lot or parcel may not exceed the lesser of 30 percent of the shoreline frontage or 200 feet”** (https://docs.legis.wisconsin.gov/code/admin_code/nr/100/115/05/1/c/2/b). We identified properties where greater than 60% of the buffer zone is in native trees, shrubs and herbaceous plants (Figure 4, shaded blue). We consider the buffer at these properties to be in good to excellent condition. Those properties not shaded should be encouraged via education and outreach to increase native plantings along their lakeshores. There are detailed descriptions of practices landowners can adopt to improve their shoreland habitat buffers in the Wisconsin Healthy Lakes Program ([Let's make Healthy Lakes together! - Wisconsin's Healthy Lakes Program \(healthylakeswi.com\)](#)) along with grants property owners can acquire to pay for the costs of these improvements.

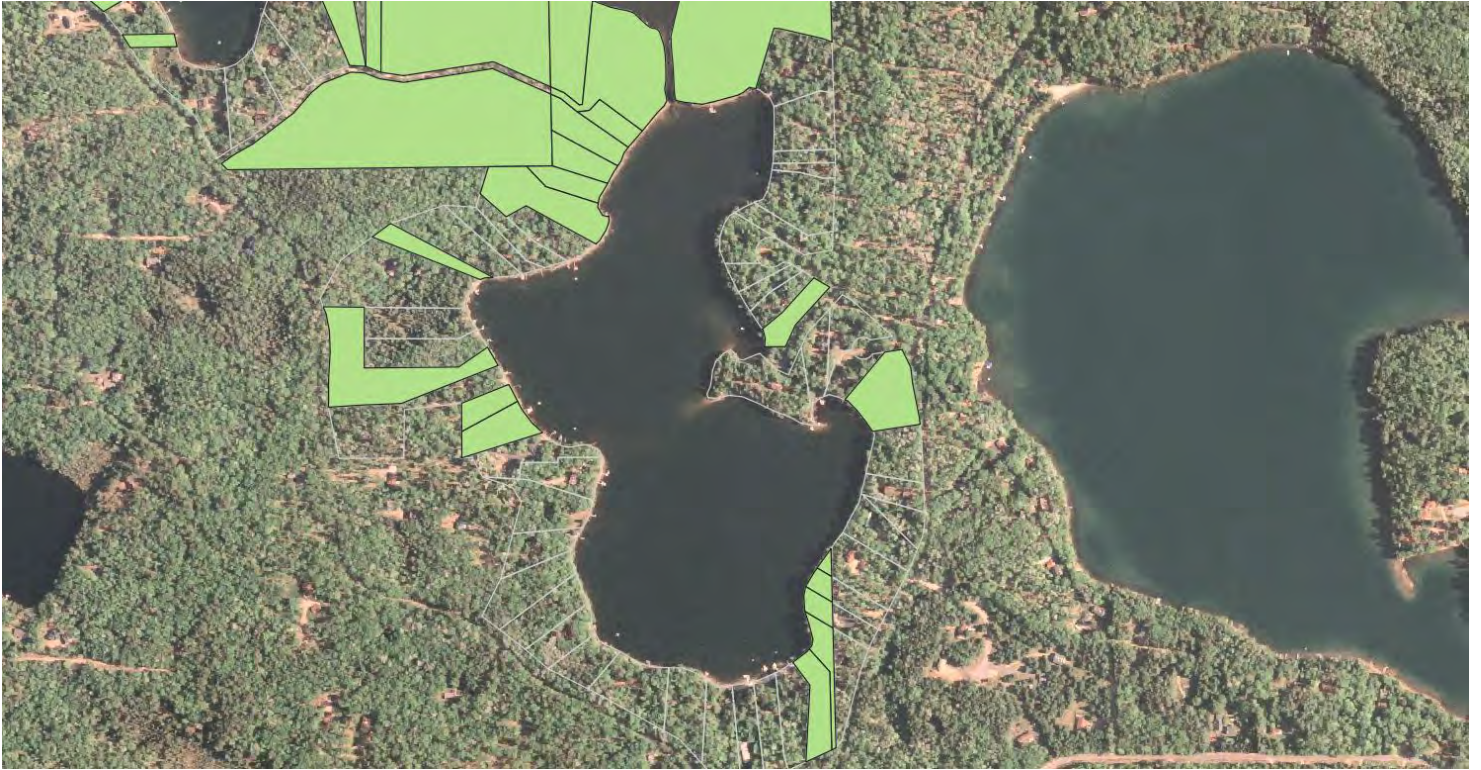
During our lake surveys we also identified shoreland properties where the buffer is in a natural shoreland condition (Figure 5, shaded green). At these properties the buffer is 90% or more in native trees, shrubs, forbs,

Figure 5. Alma Lake tax parcels shaded in light green have shoreland buffers in a natural state – where greater than 90% of the area is in native trees, shrubs, and herbaceous plants.

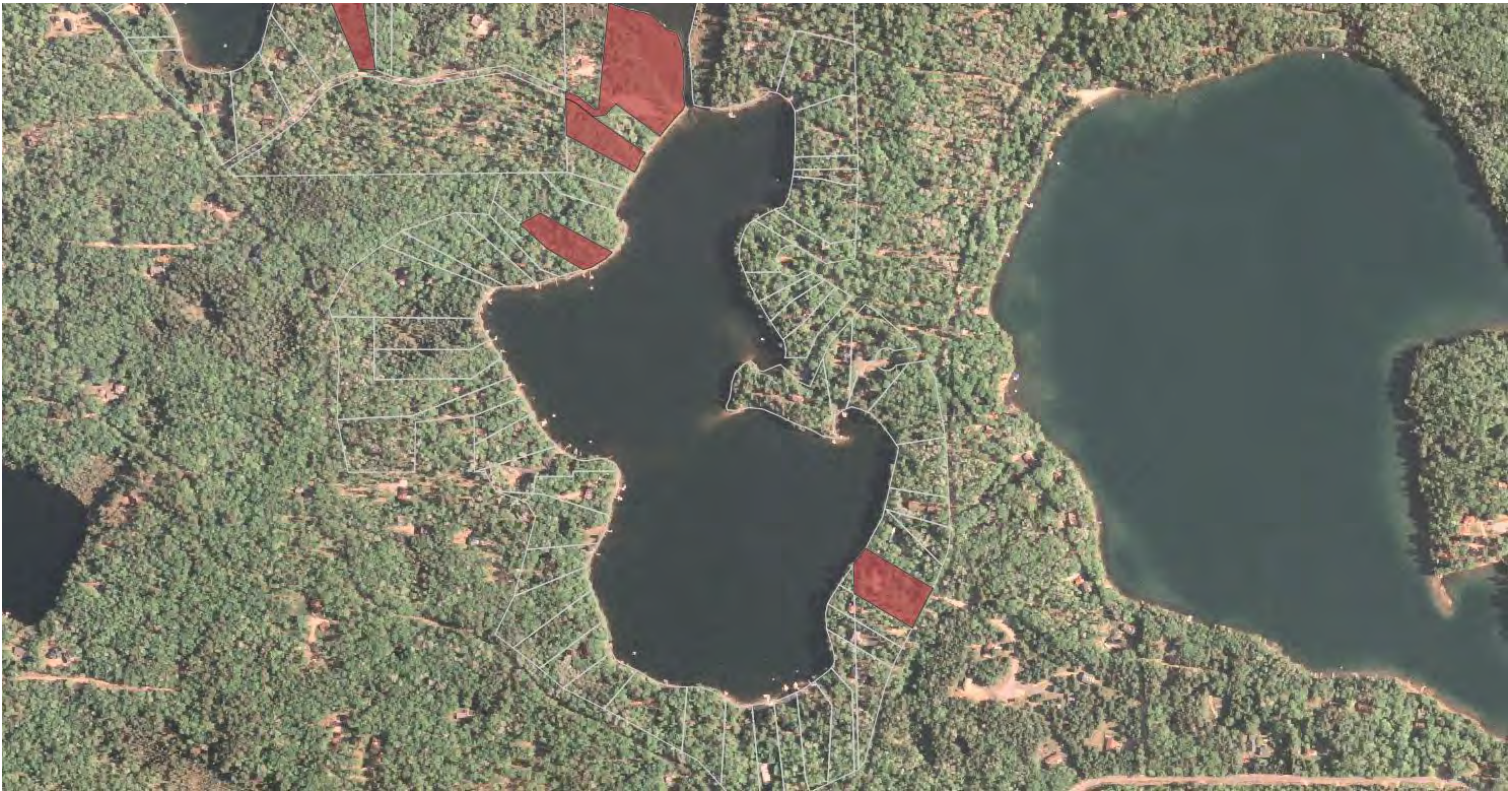
Shoreland erosion issues are not a great concern on Alma Lake, despite the high level of development and relatively steep slopes on parts of the lake. Lakeshore development for housing and recreation can result in removal of native vegetation, disturbance of soil, and introduction of impervious surfaces such as concrete, roof tops, asphalts – materials where rainfall and snow melt cannot percolate through to the soil. The parcels shaded brown in Figure 6 represent parcels where surface water run-off was creating shoreland erosion and/or gullying. These parcels can be improved by implementing practices to redirect overland movement of precipitation and snowmelt. There are detailed descriptions of practices landowners can adopt to decrease shoreland run-off in the Wisconsin Healthy Lakes Program ([Let's make Healthy Lakes together! - Wisconsin's Healthy Lakes Program \(healthylakeswi.com\)](http://www.healthylakeswi.com)) along with application for grants property owners can obtain to pay for the costs of these improvements.

Figure 6a. Alma Lake tax parcels shaded in brown have evidence of shoreland run-off from rainfall and/or snow melt.

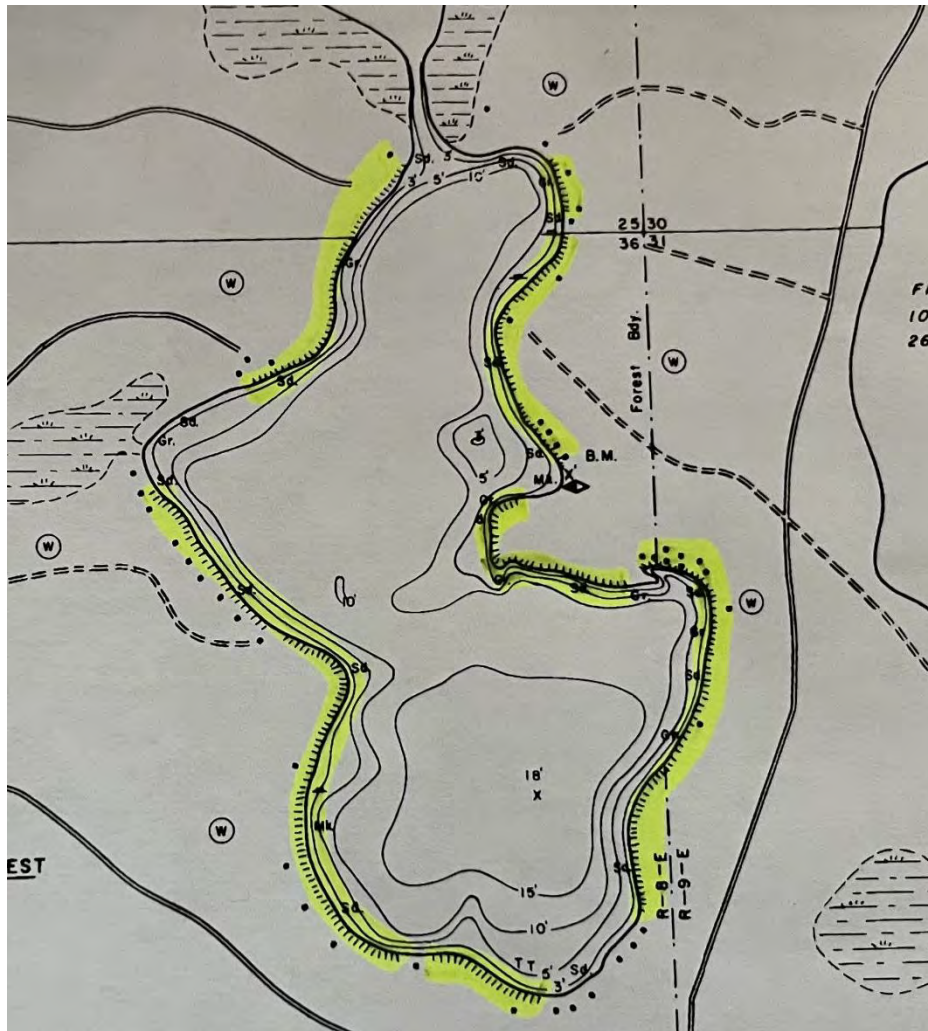
Figure 6b. Location of steep slopes in the Alma Lake shoreland as identified by WDNR lake bathymetry map. Hatch marks shaded in yellow = steep slopes. [Alma Lake - Vilas County, Wisconsin DNR Lake Map, Sep 1977, Not for Navigation](#)

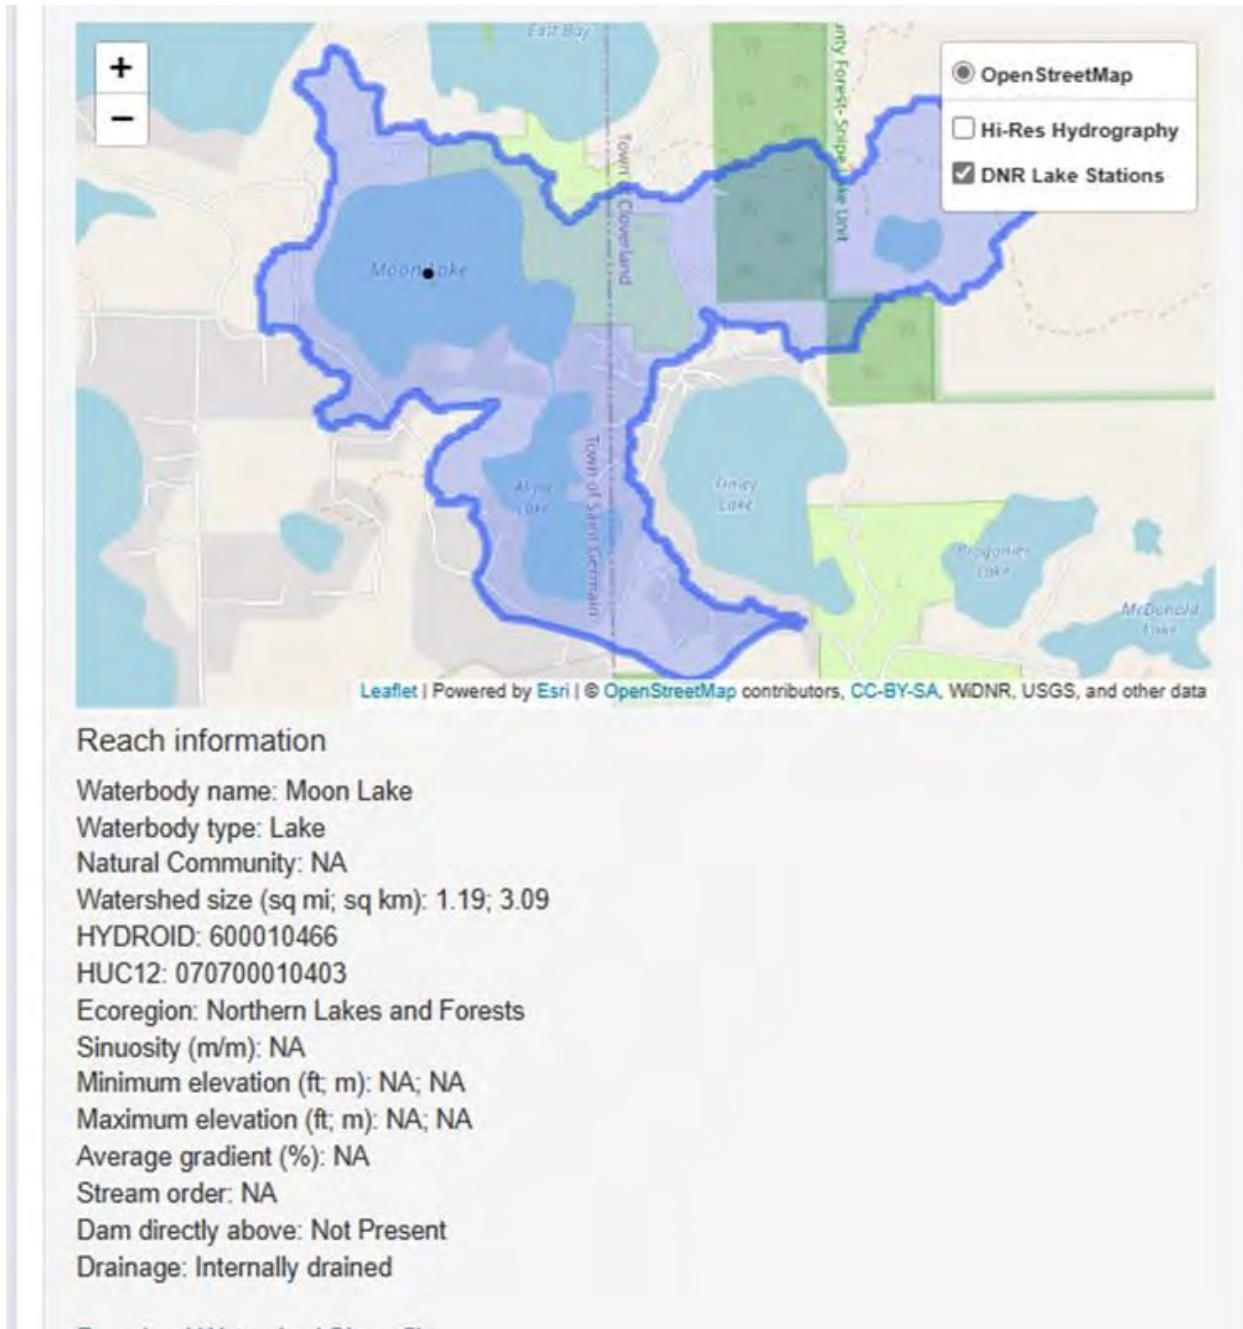
Figure 9. Land Area Draining to Moon Lake. Moon Lake was assessed by WDNR and is not considered impaired under Wisconsin’s Consolidated Assessment and Listing Methodology (WisCALM) and meets water quality standards. The lake supports a warmwater fishery and is managed for panfish, northern pike, musky, largemouth bass, smallmouth bass, and walleye. All of Moon Lake shoreline is in private ownership.

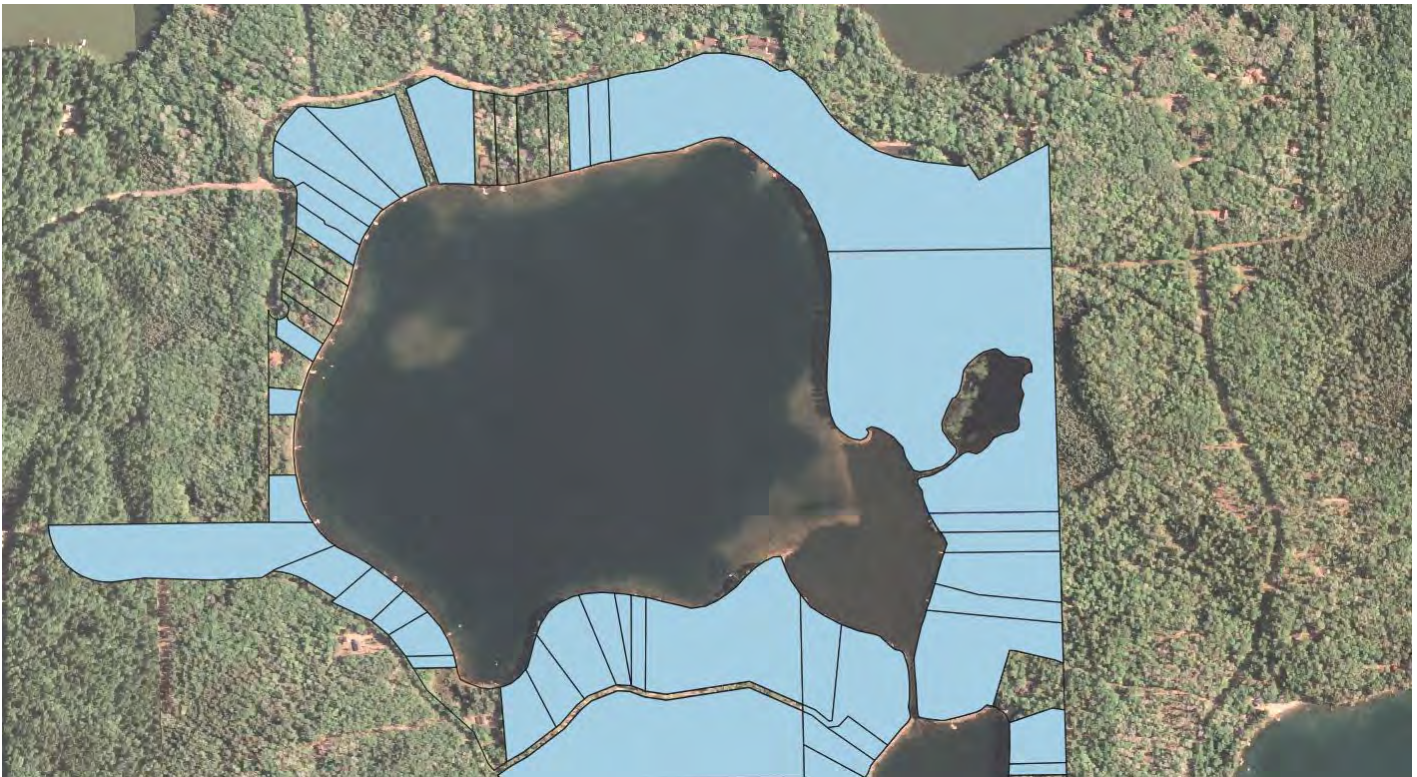
Figure 10. Moon Lake tax parcels shaded in blue have shoreland with greater than 60% of the buffer area in native trees, shrubs, forbs, and grasses.

Shoreland development often degrades the habitat quality of lakeshore buffer zones. In this study, we define the buffer zone to be from the ordinary high-water mark (OHWM) to 35' inland. Manicured lawns reduce wildlife habitat, and impervious surfaces (rooftops, driveways, patios, etc.) increase nutrient and sediment run-off. Lake managers recommend leaving at least 70% of the buffer in native vegetation. As stated in Wisconsin Shoreland Zoning Minimum Standards ([Wisconsin's Shoreland Management Program | Wisconsin DNR](#) NR115.05(3)(c), Wis. Admin. Code): **“The county may allow removal of trees and shrubs in the vegetative buffer zone to create access and viewing corridors, provided that the combined width of all access and viewing corridors on a riparian lot or parcel may not exceed the lesser of 30 percent of the shoreline frontage or 200 feet”** (https://docs.legis.wisconsin.gov/code/admin_code/nr/100/115/05/1/c/2/b). We identified properties where greater than 60% of the buffer zone is in native trees, shrubs and herbaceous plants (Figure 10, shaded blue). We consider the buffer at these properties to be in good to excellent condition. Those properties not shaded should be encouraged via education and outreach to increase native plantings along their lakeshores. There are detailed descriptions of practices landowners can adopt to improve their shoreland habitat buffers in the Wisconsin Healthy Lakes Program ([Let's make Healthy Lakes together! - Wisconsin's Healthy Lakes Program \(healthylakeswi.com\)](#)) along with grants property owners can acquire to pay for the costs of these improvements.

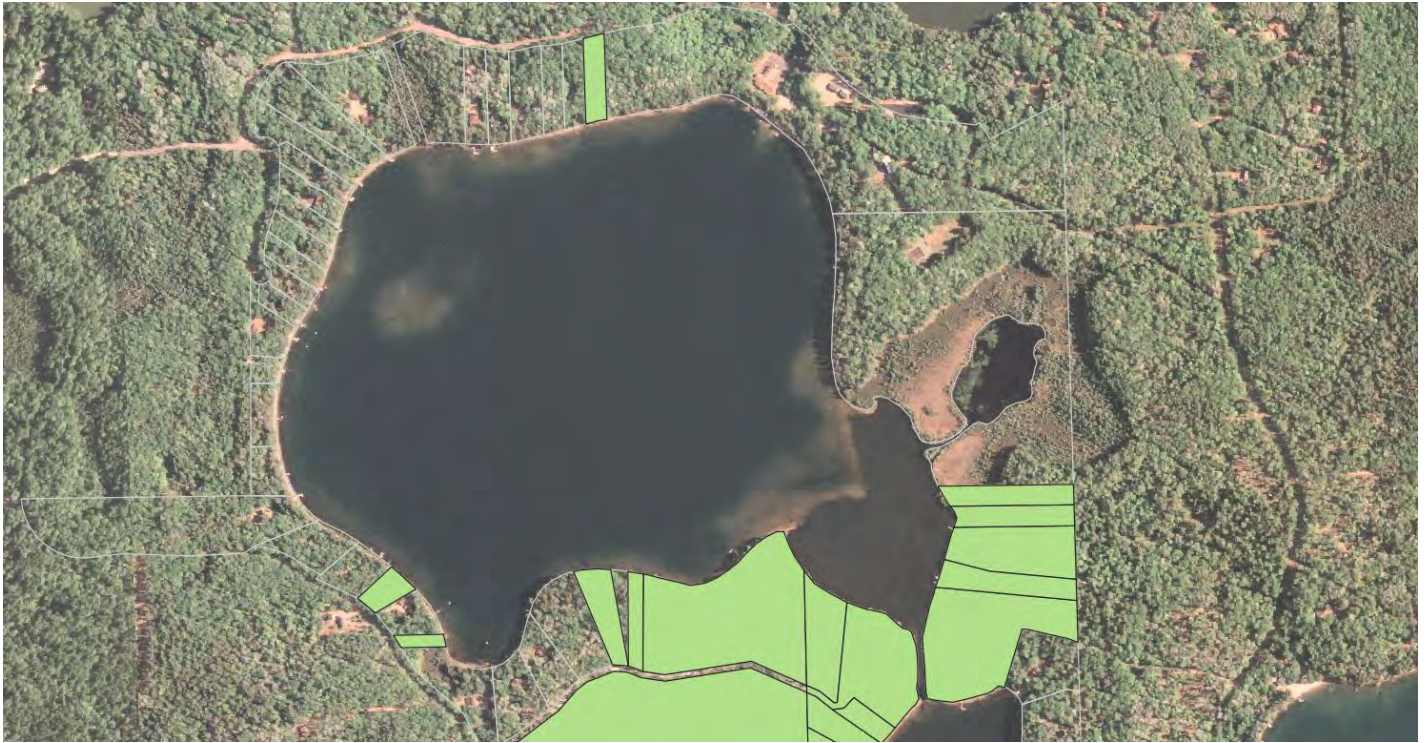
During our lake surveys we also identified shoreland properties where the buffer is in a natural shoreland condition (Figure 11, shaded green). At these properties the buffer is 90% or more in native trees, shrubs, forbs, and grasses. These properties meet one of the criteria included in designating Critical Habitat – and these shorelands should be protected.

Figure 11. Moon Lake tax parcels shaded in light green have shoreland buffers in a natural state – where greater than 90% of the area is in native trees, shrubs, and herbaceous plants.

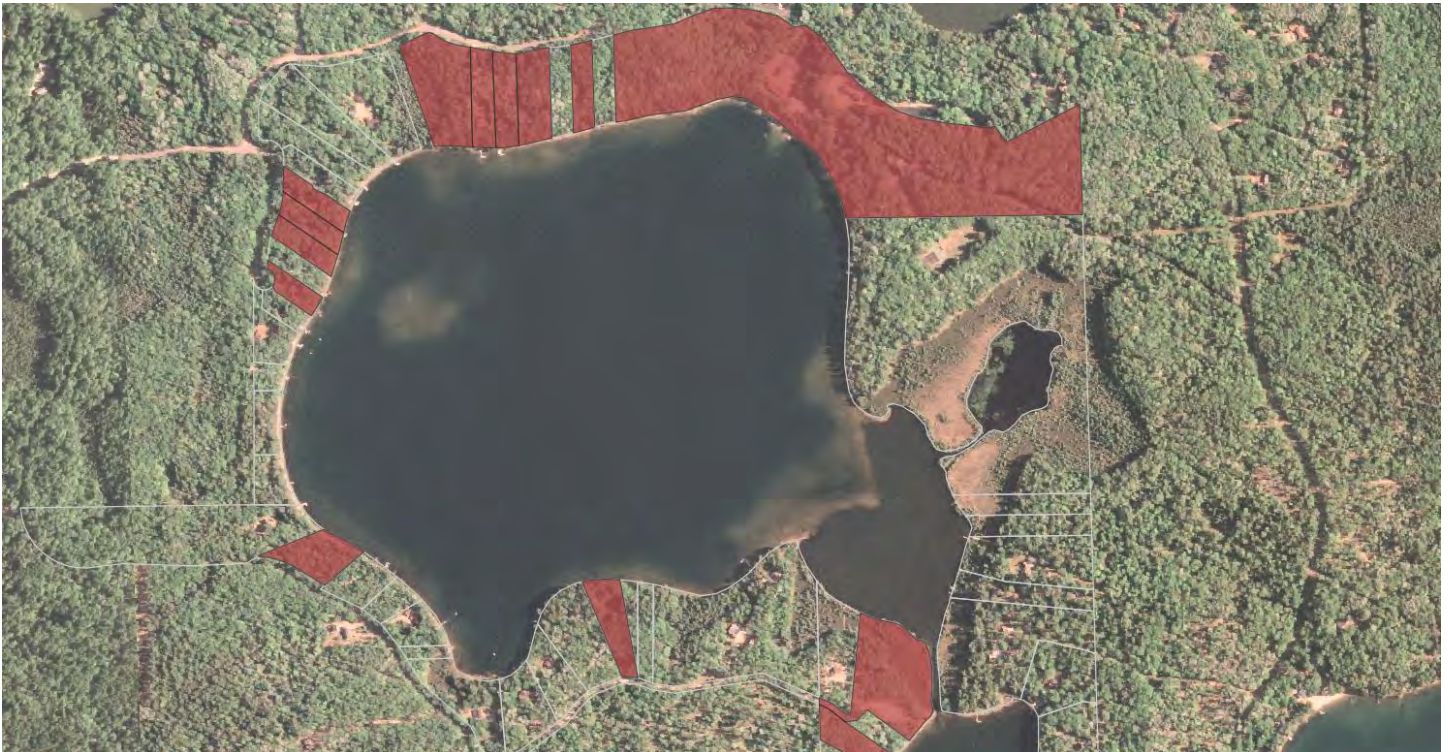
Shoreland erosion issues were observed on Moon Lake, but only moderate erosion was present when it occurred. Erosion is most evident in the north and west quadrant of the lake where there is a high level of development and relatively steep slopes on parts of the lakeshore. Development for housing and recreation can result in removal of native vegetation, disturbance of soil, and introduction of impervious surfaces such as concrete, roof tops, asphalts – any materials where rainfall and snow melt cannot percolate through to the soil. The parcels shaded brown in Figure 12a represent parcels where surface water run-off was creating shoreland erosion and/or gullying. Steep slopes dominate the Moon Lake shorelands (Figure 12b) thus landowners should be diligent to prevent the development of shoreland erosion problems. These parcels can be improved by implementing practices to redirect overland movement of precipitation and snowmelt. There are detailed descriptions of practices landowners can adopt to decrease shoreland run-off in the Wisconsin Healthy Lakes Program ([Let's make Healthy Lakes together! - Wisconsin's Healthy Lakes Program \(healthy lakeswi.com\)](http://healthy lakeswi.com)) along with application for grants property owners can obtain to pay for the costs of these improvements.

Figure 12a. Moon Lake tax parcels shaded in brown have evidence of shoreland run-off from rainfall and/or snow melt.

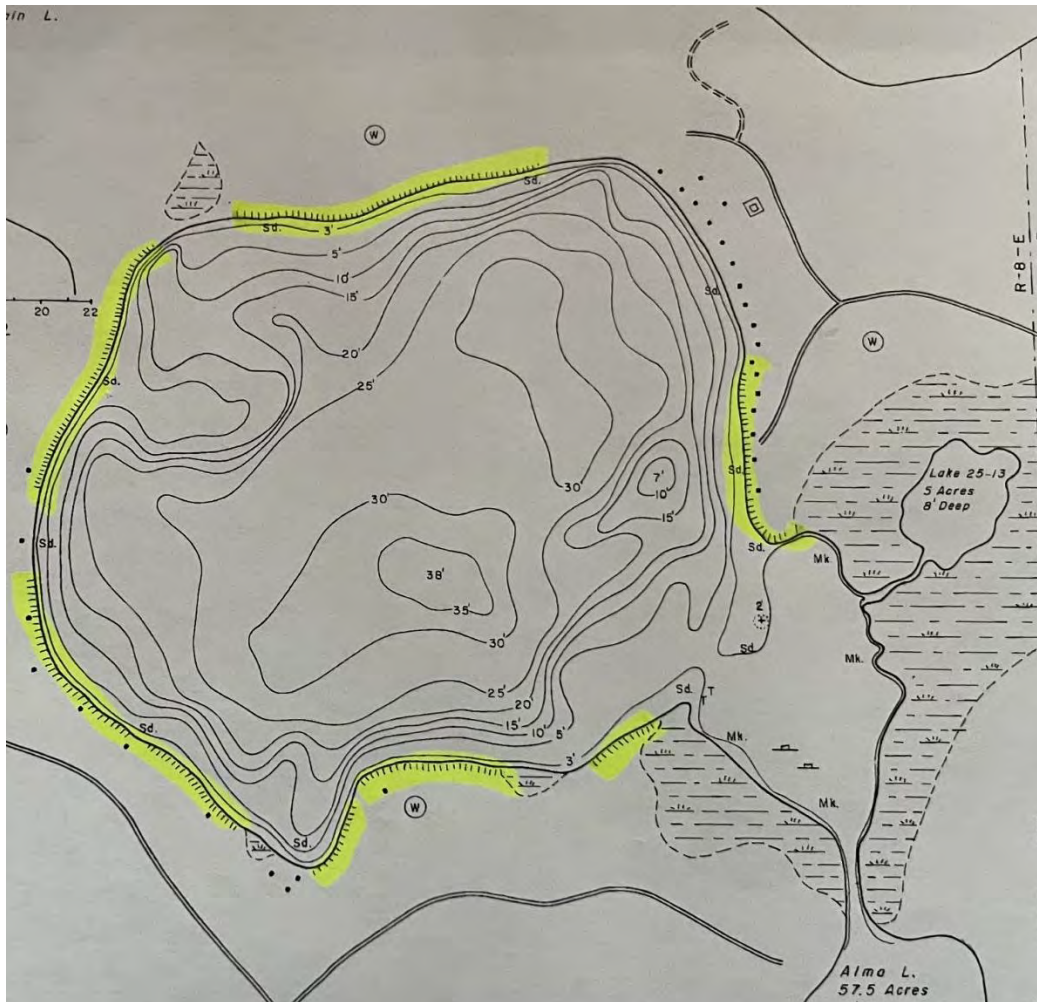
Figure 12b. Location of steep slopes in the Moon Lake shoreland as identified by WDNR lake bathymetry map. Hatch marks shaded in yellow = steep slopes. [Moon Lake - Vilas County, Wisconsin DNR Lake Map, Sep 1977, Not for Navigation](#)

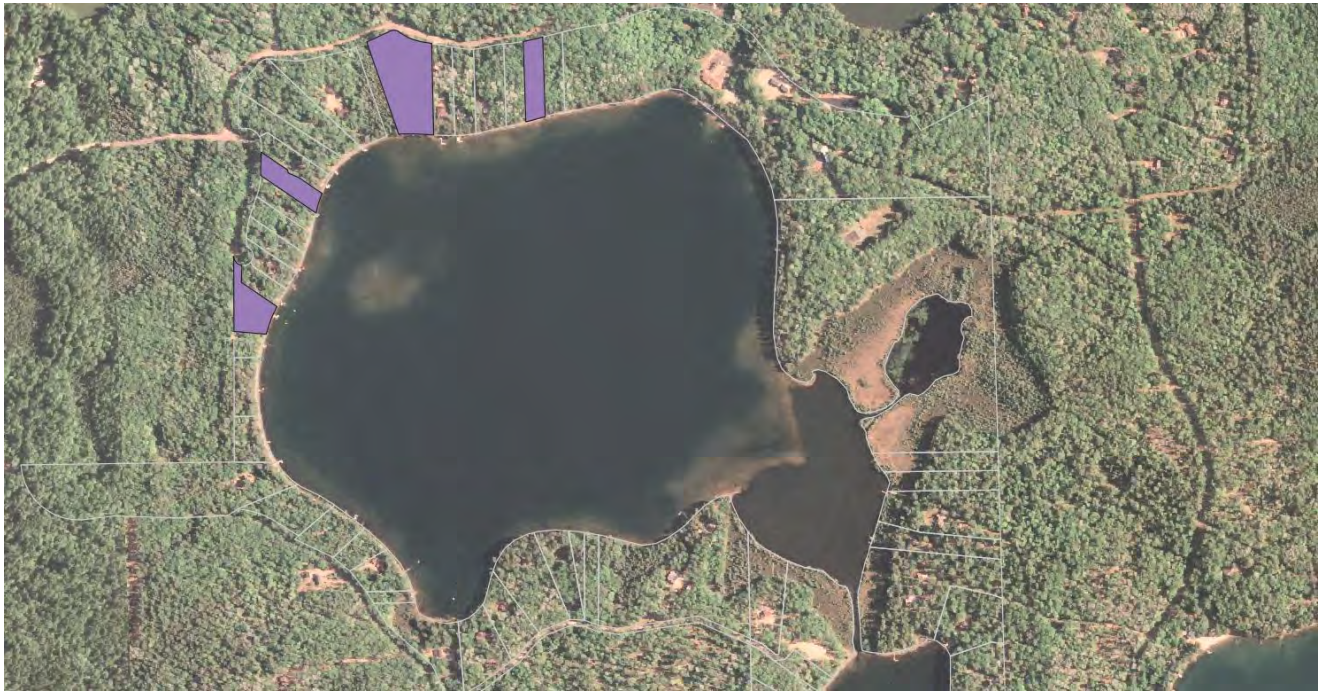
Wave action and boat wakes can also result in bank erosion, the loss of shoreland habitat right at the water's edge. Despite the high level of shoreland development, bank erosion was limited to a few parcels in the north and west shoreland areas (Figure 13).

Figure 13. Moon Lake tax parcels where bank erosion was observed.

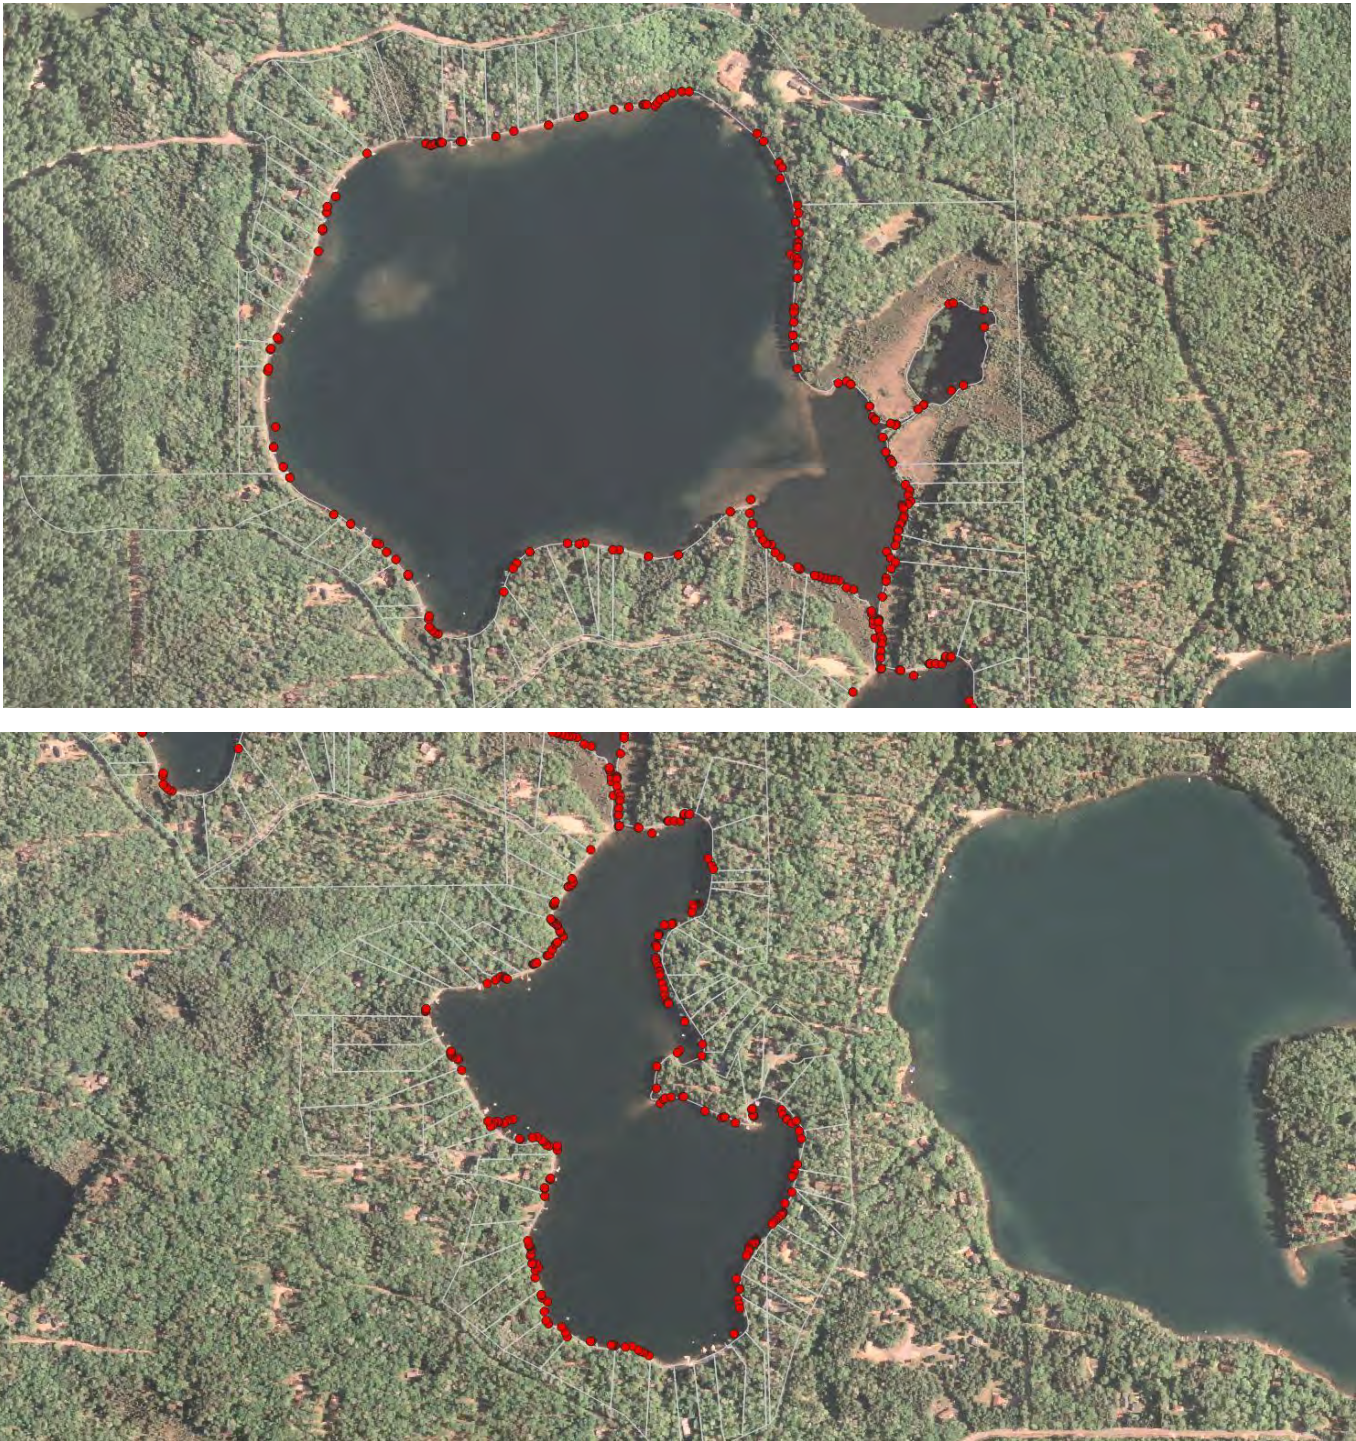
Waypoints were collected of all coarse wood (pieces >4" diameter, >5' length) along the shoreline of Alma and Moon Lakes (Figure 14). The individual coarse wood was further delineated as submerged logs, logs touching shore, full tree crowns, and logs with some branching, following the Hein et al. (2020) protocol. While not equally distributed, there were 231 pieces of coarse wood on Alma Lake, or 140 pieces per mile of shoreline. While the best structure for fish habitat is downed trees with whole crowns, only 4 of the 231 pieces (2%) on Alma Lake were of that type. An additional 14 pieces of coarse wood had some branching (6%), but the majority were either submerged logs or logs touching the shore (203 pieces – 92%). Moon Lake had less coarse wood per mile shoreline (190 pieces, 96 pieces/mile) but it was of greater habitat value with 22 downed trees with crowns (12%), 38 pieces of downed wood with some branching (20%), and 130 submerged logs or logs touching shore (62%).

Figure 14. Red dots represent waypoints of all coarse wood (pieces >4" diameter, >5' length) along the shoreline of Alma and Moon Lakes

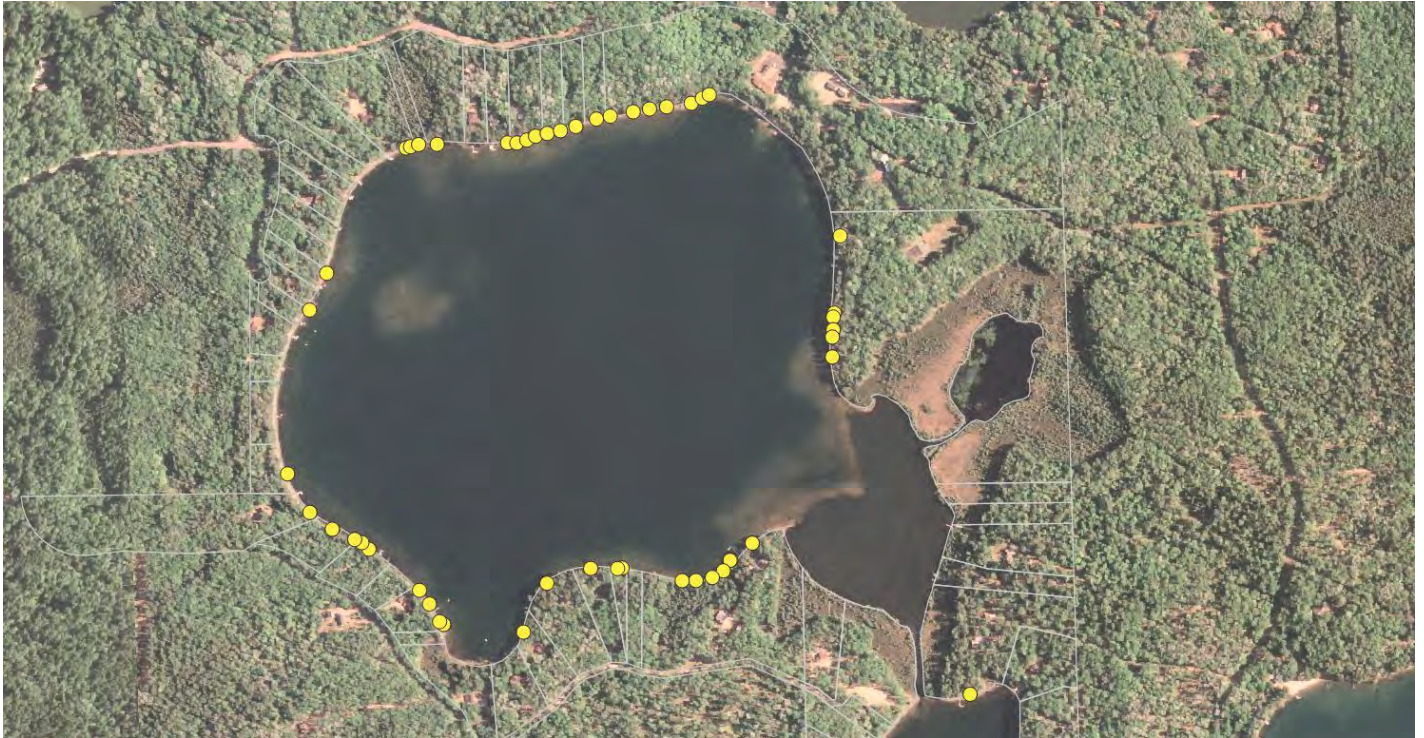
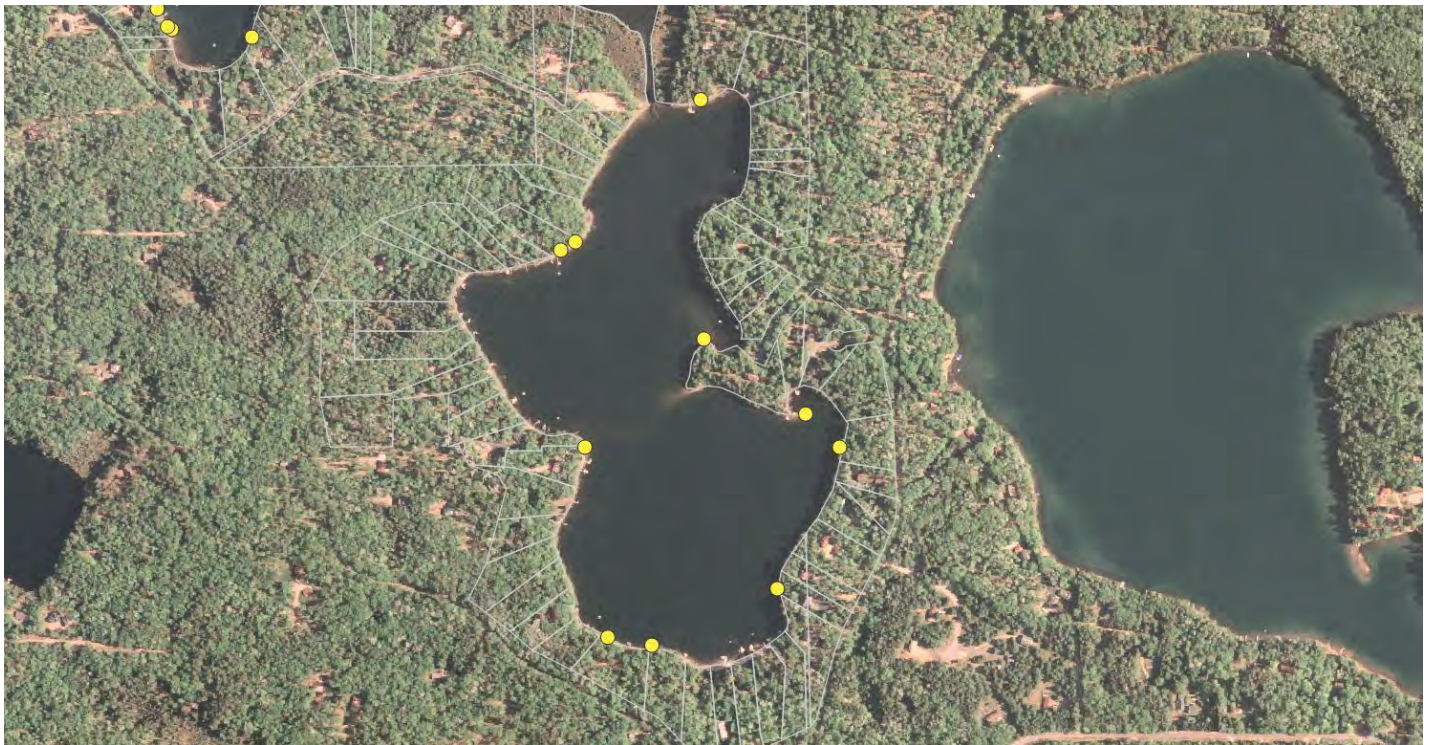
other areas of the lake. Mostly, these were narrow bands of gravel with little rock or rubble on Moon Lake. Differently, there were few and small extents of gravel on Alma Lake.

Figure 15. Waypoints (yellow dots) were collected at shorelines where the lake bottom is dominated by rock, rubble and gravel during the fish habitat surveys in May 2023.

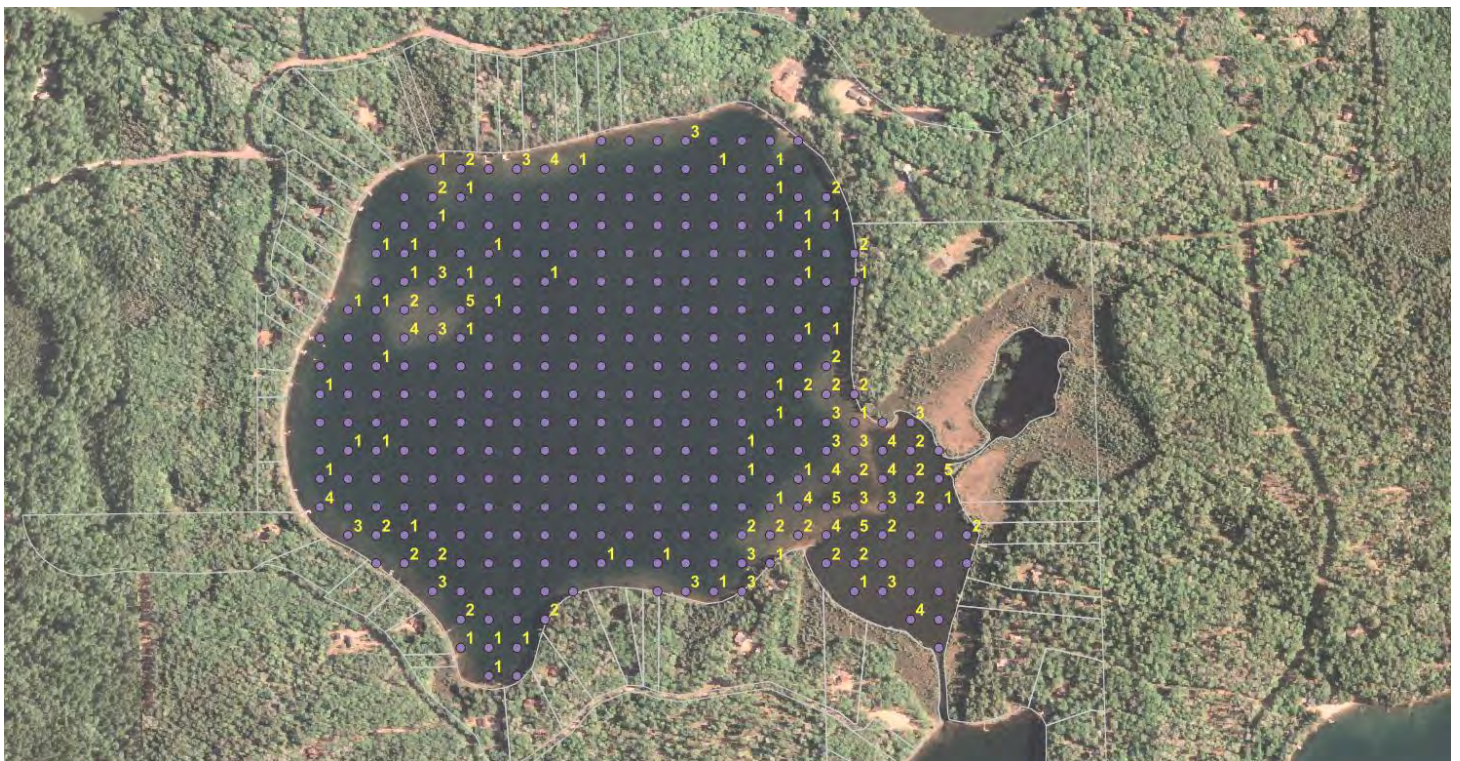
Twenty-five species of plants were found on Moon Lake in 2010 and twenty-two in 2019. The mean C (coefficient of conservatism) was 7.7 in 2010 and 6.63 in 2019 and the Floristic Quality Index (FQI) was 31.09 and 28.9. The median values for the Northern Lakes and Forest Ecoregion (Nichol's) are Floristic Quality (FQI)-24.3, number of species (N)-13, and Average Conservatism (C)-6.2. Moon Lake exceeds the average in all categories. The maximum depth of plant growth was 26 feet. The results indicate a diverse plant community. Extensive native species plant beds occur in the southeast bay and in the northwest quadrat. It is recommended that another plant survey be conducted on Moon Lake in 2024. An invasive species survey was conducted in 2005. Chinese Mystery Snail were found. No invasive aquatic plants were detected.

Figure 16. Purple dots represent the location of 2019 Point-intercept sampling on Moon Lake. Yellow numerals represent the number of native plant species at each sample point.

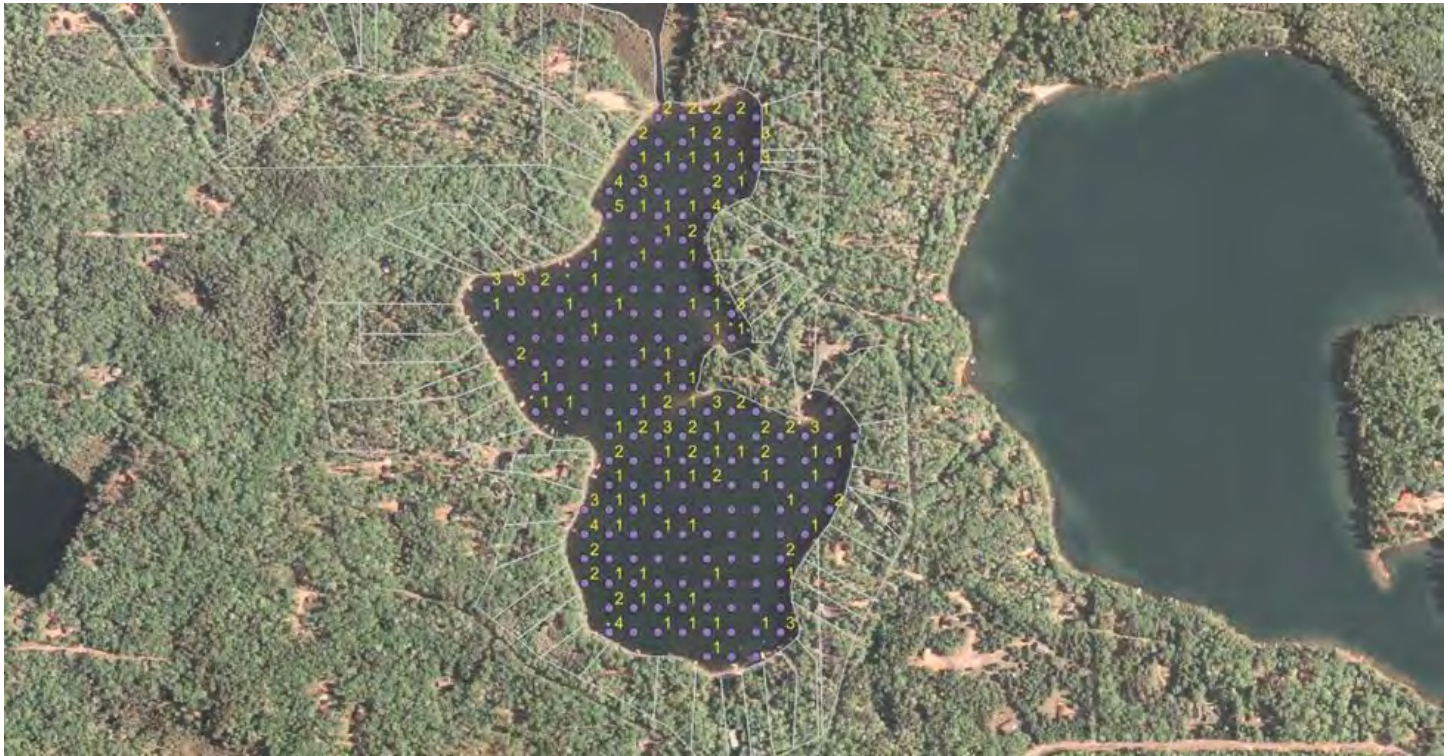
Twenty-one species of plants were found on Alma Lake in 2010 and 20 species in 2019. The mean C (coefficient of conservatism) was 7.9 in 2010 and 6.85 in 2019 and the Floristic Quality Index (FQI) was 36.4 and 30.63. The median values for the Northern Lakes and Forest Ecoregion (Nichol's) are Floristic Quality (FQI)-24.3, number of species (N)-13, and Average Conservatism (C)-6.2. Alma Lake exceeds the average in all categories. The maximum depth of plant growth was 20 feet. The results indicate a diverse plant community. It is recommended that another plant survey be conducted on Alma Lake in 2024 to track trends. An invasive

Figure 17. Purple dots represent the location of 2019 Point-intercept sampling Alma Lake. Yellow numerals represent the number of native plant species at each sample point.
