Shoreland Assessments and Critical Habitat Mapping of Alma and Moon Lakes, Vilas County, Wisconsin

Mike Meyer and Jim Kreitlow
NOVA Ecological Services
Boulder Junction, WI 54512
(novaecologicalservies@outlook.com)

June 18, 2024

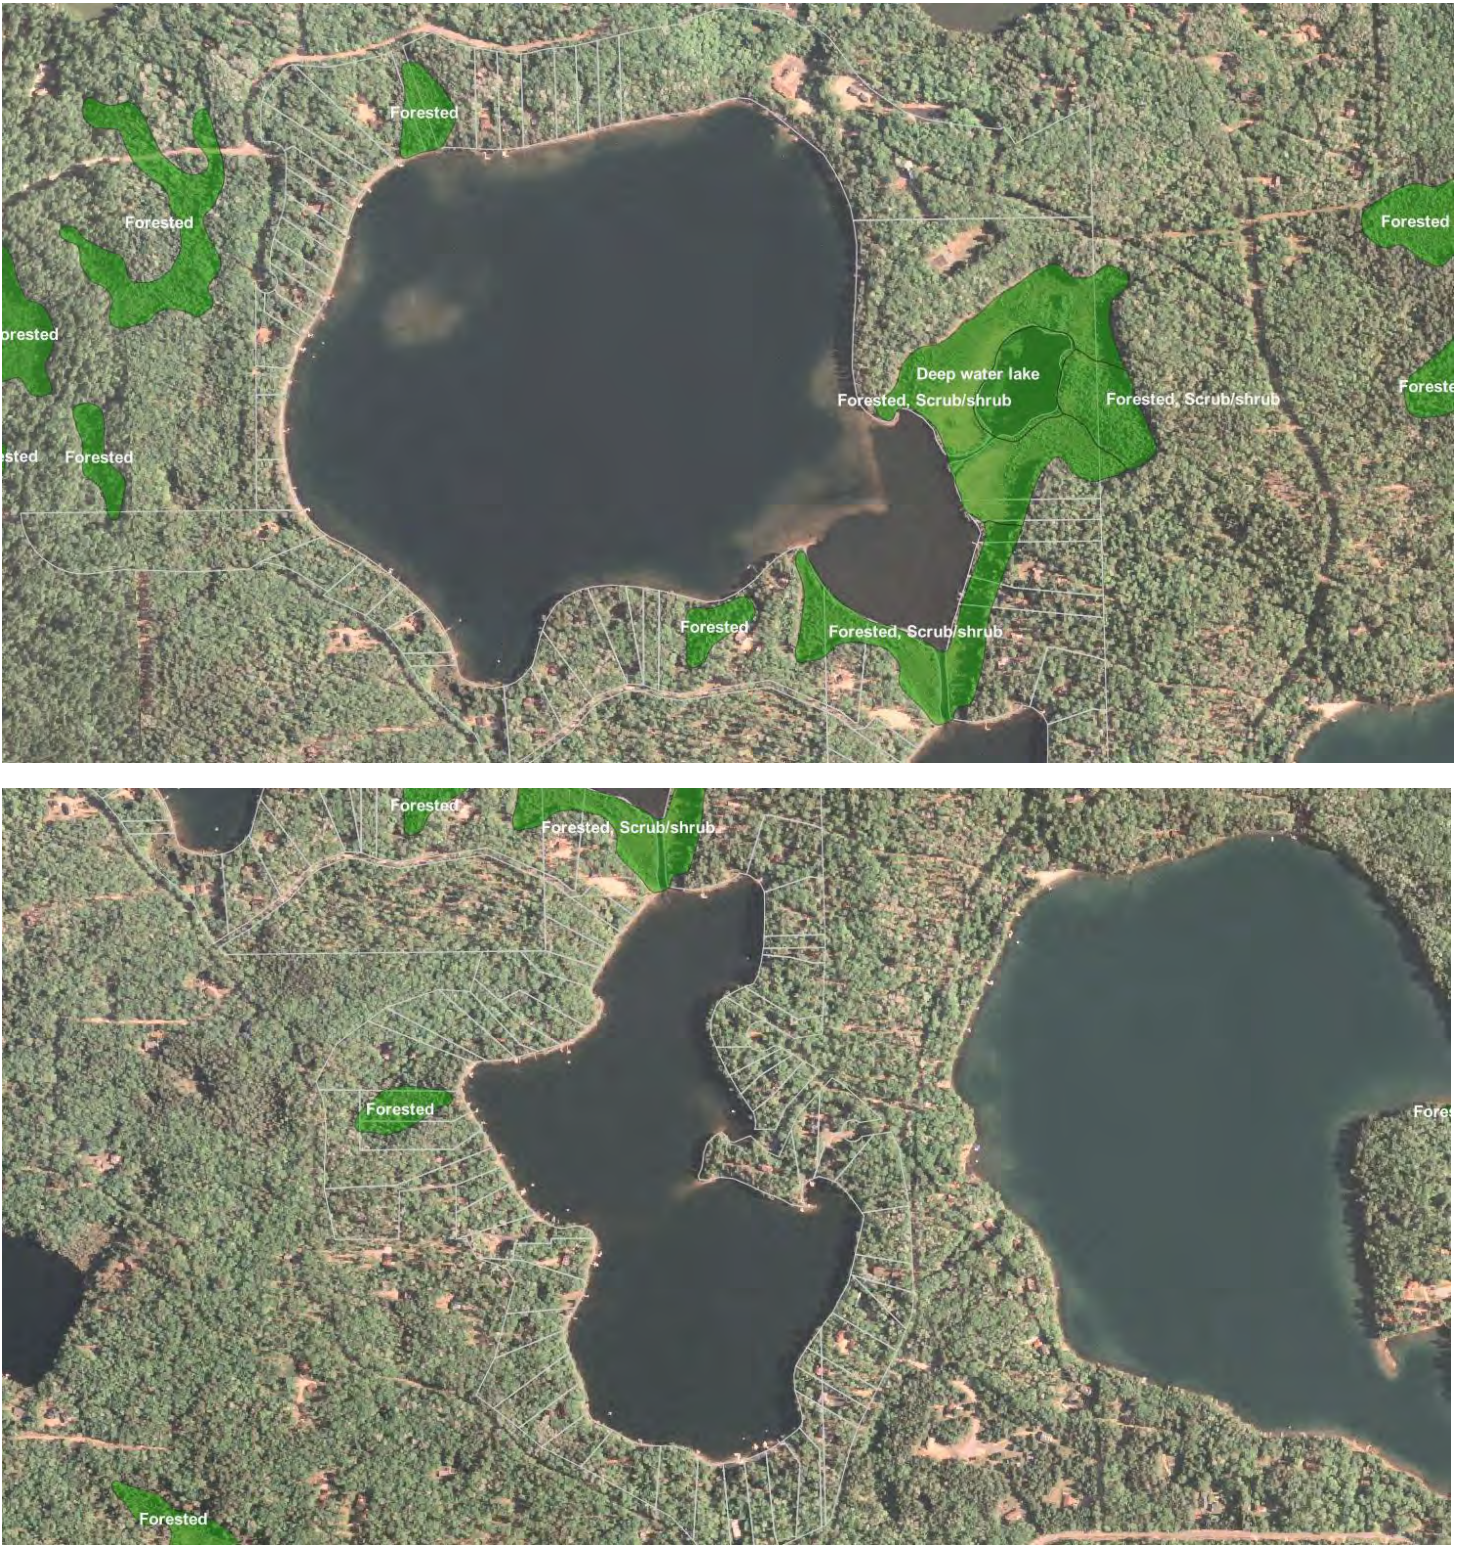
We obtained Wisconsin Wetland Inventory shapefiles for the survey area from the WDNR which show graphic representations of the type, size, and location of wetlands in proximity to Alma and Moon Lakes. These maps have been prepared from the analysis of high-altitude imagery in conjunction with soil surveys, topographic maps, previous wetland inventories and field work. We used QGIS to produce a geo-referenced overlay of wetlands adjacent to Alma and Moon Lakes (Figure 18). The wetland descriptions and naming follow the Wisconsin Wetland Inventory Classification Guide (1992) WDNR Publ. WZ-WZ023. Wetlands predominate the shoreline of the southeast bay of Moon Lake, Engel Lake, and the channel between Alma and Moon Lakes. Only small patches of wetland shoreline are found on the remainder of Moon Lake and only one small area on Alma Lake.

Figure 18. Green polygons show the type, size, and location of wetlands in proximity to Alma and Moon Lakes.

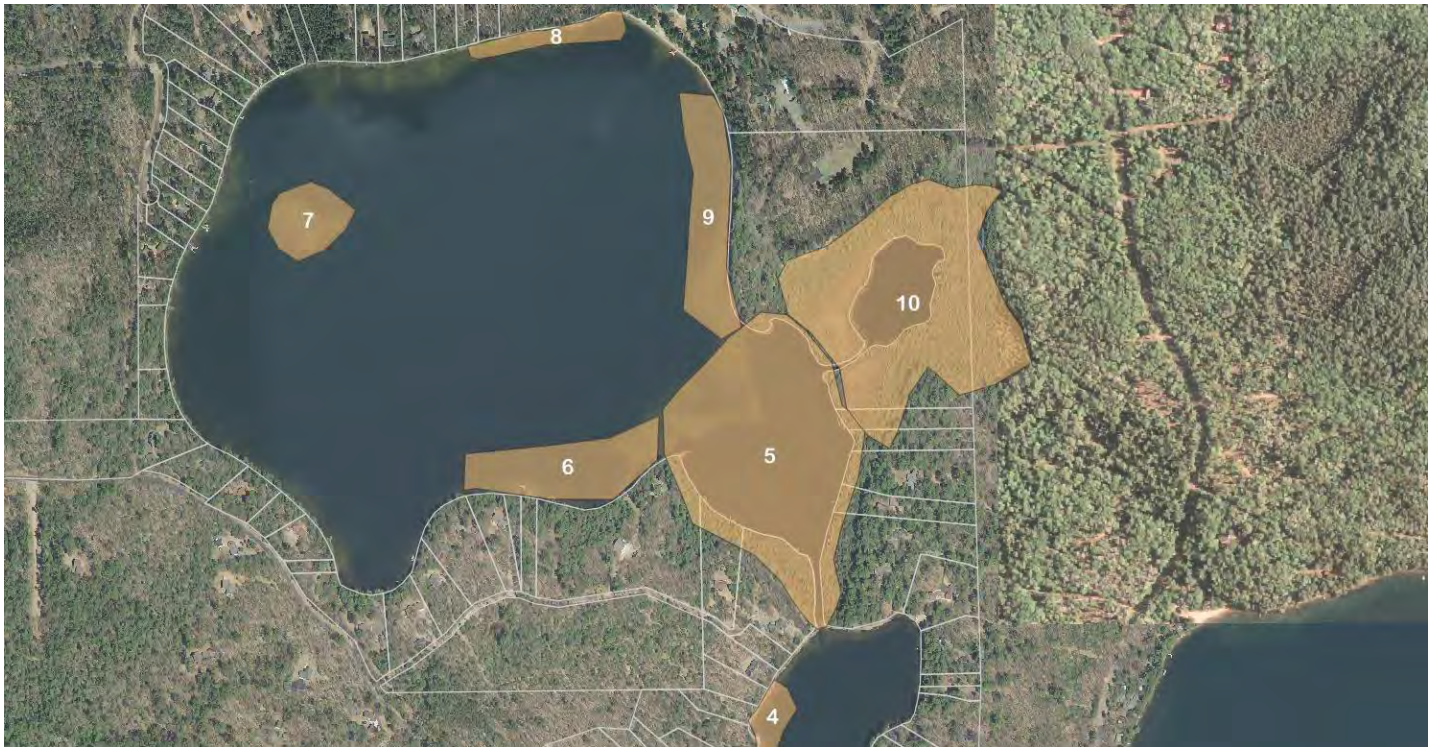
Figure 19. Location of the six areas on Moon Lake recommended for consideration as Critical Habitat (orange shading) by Nova Ecological Services during 2023 surveys and adjacent properties (white lines)

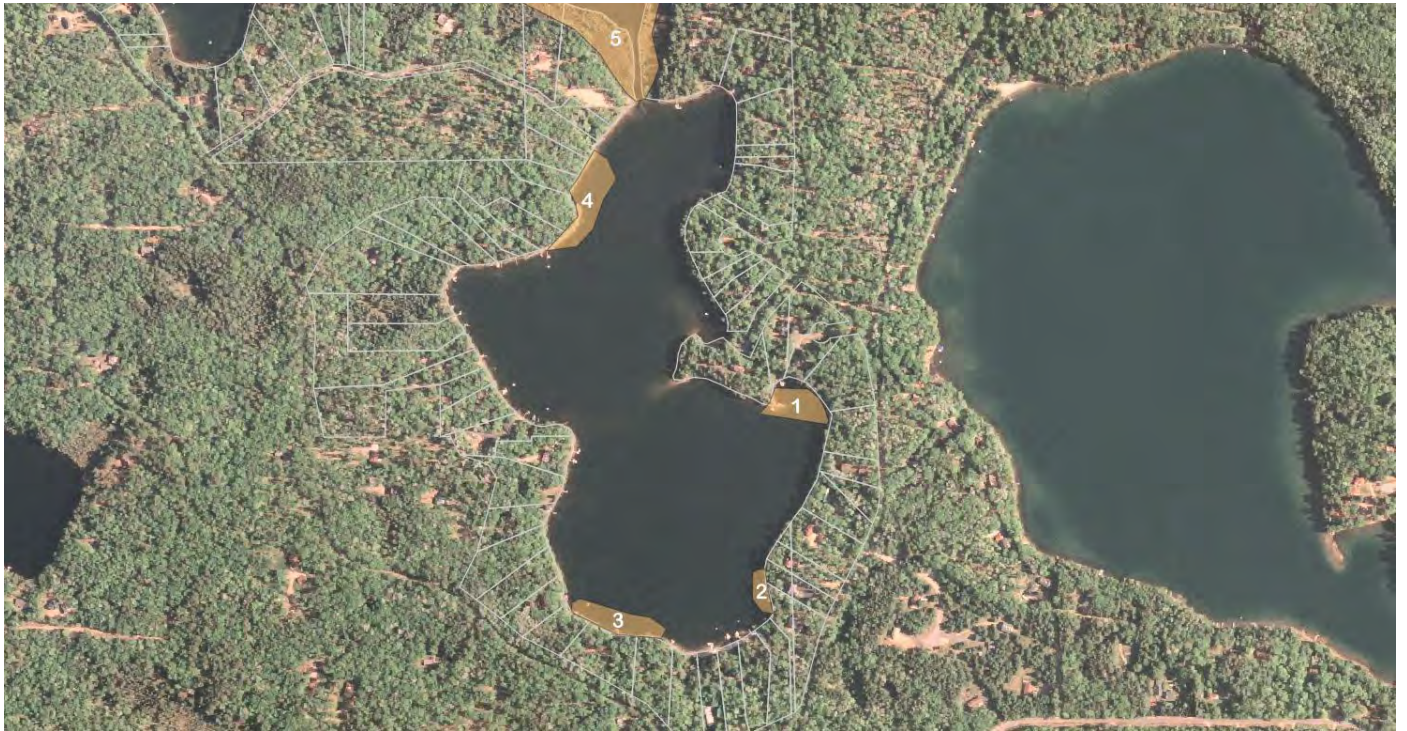
Figure 20. Location of the four areas on Alma Lake recommended for consideration as Critical Habitat (orange shading) by Nova Ecological Services during 2023 surveys and adjacent property lines (white lines).

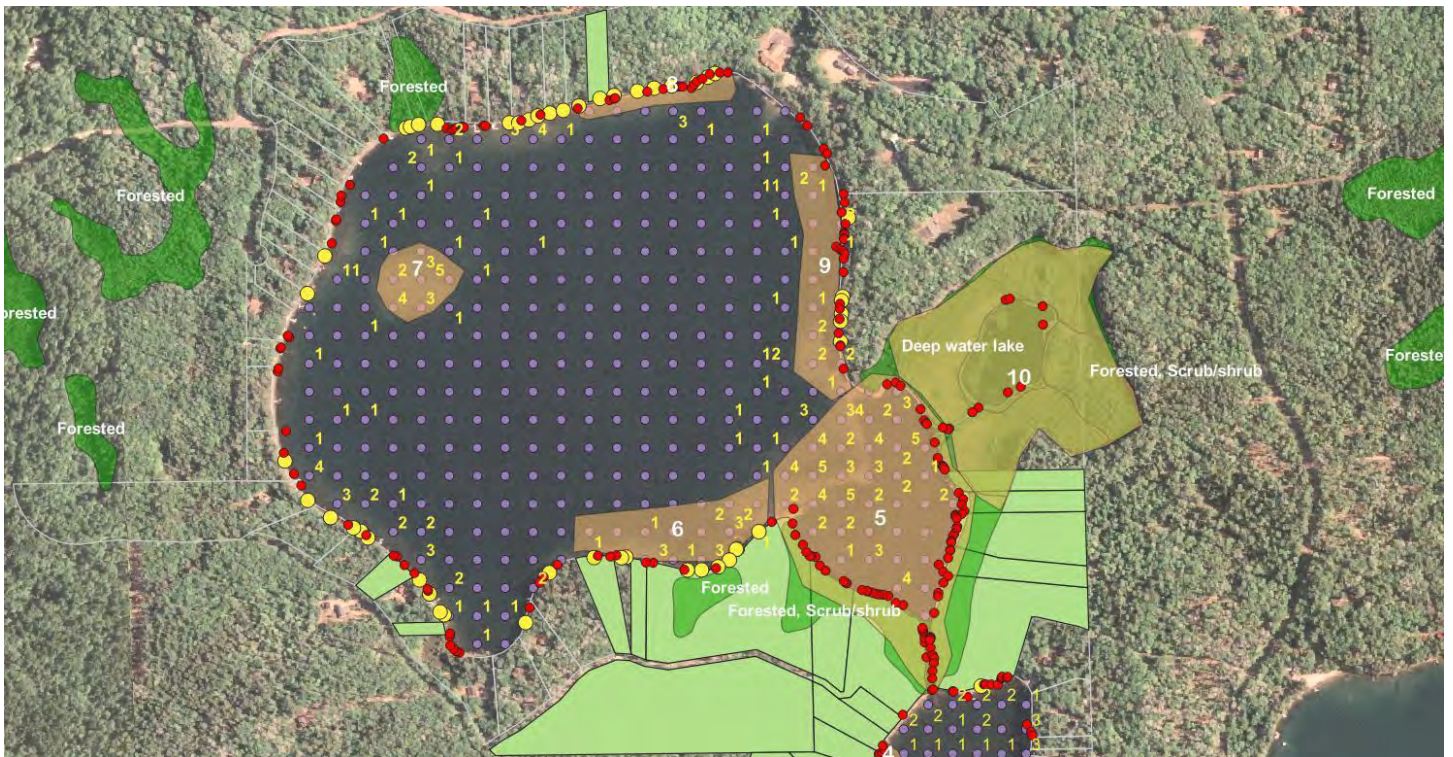
Figure 21. Location of Moon Lake Critical Habitat sites (orange polygons, white numerals) in relation to natural features (red dots=coarse wood; yellow dots=rock/rubble/gravel; purple dots and yellow numerals=2019 Onterra PI Survey results with number of native species per point; light green polygons=natural shoreland; dark green polygons=wetlands).

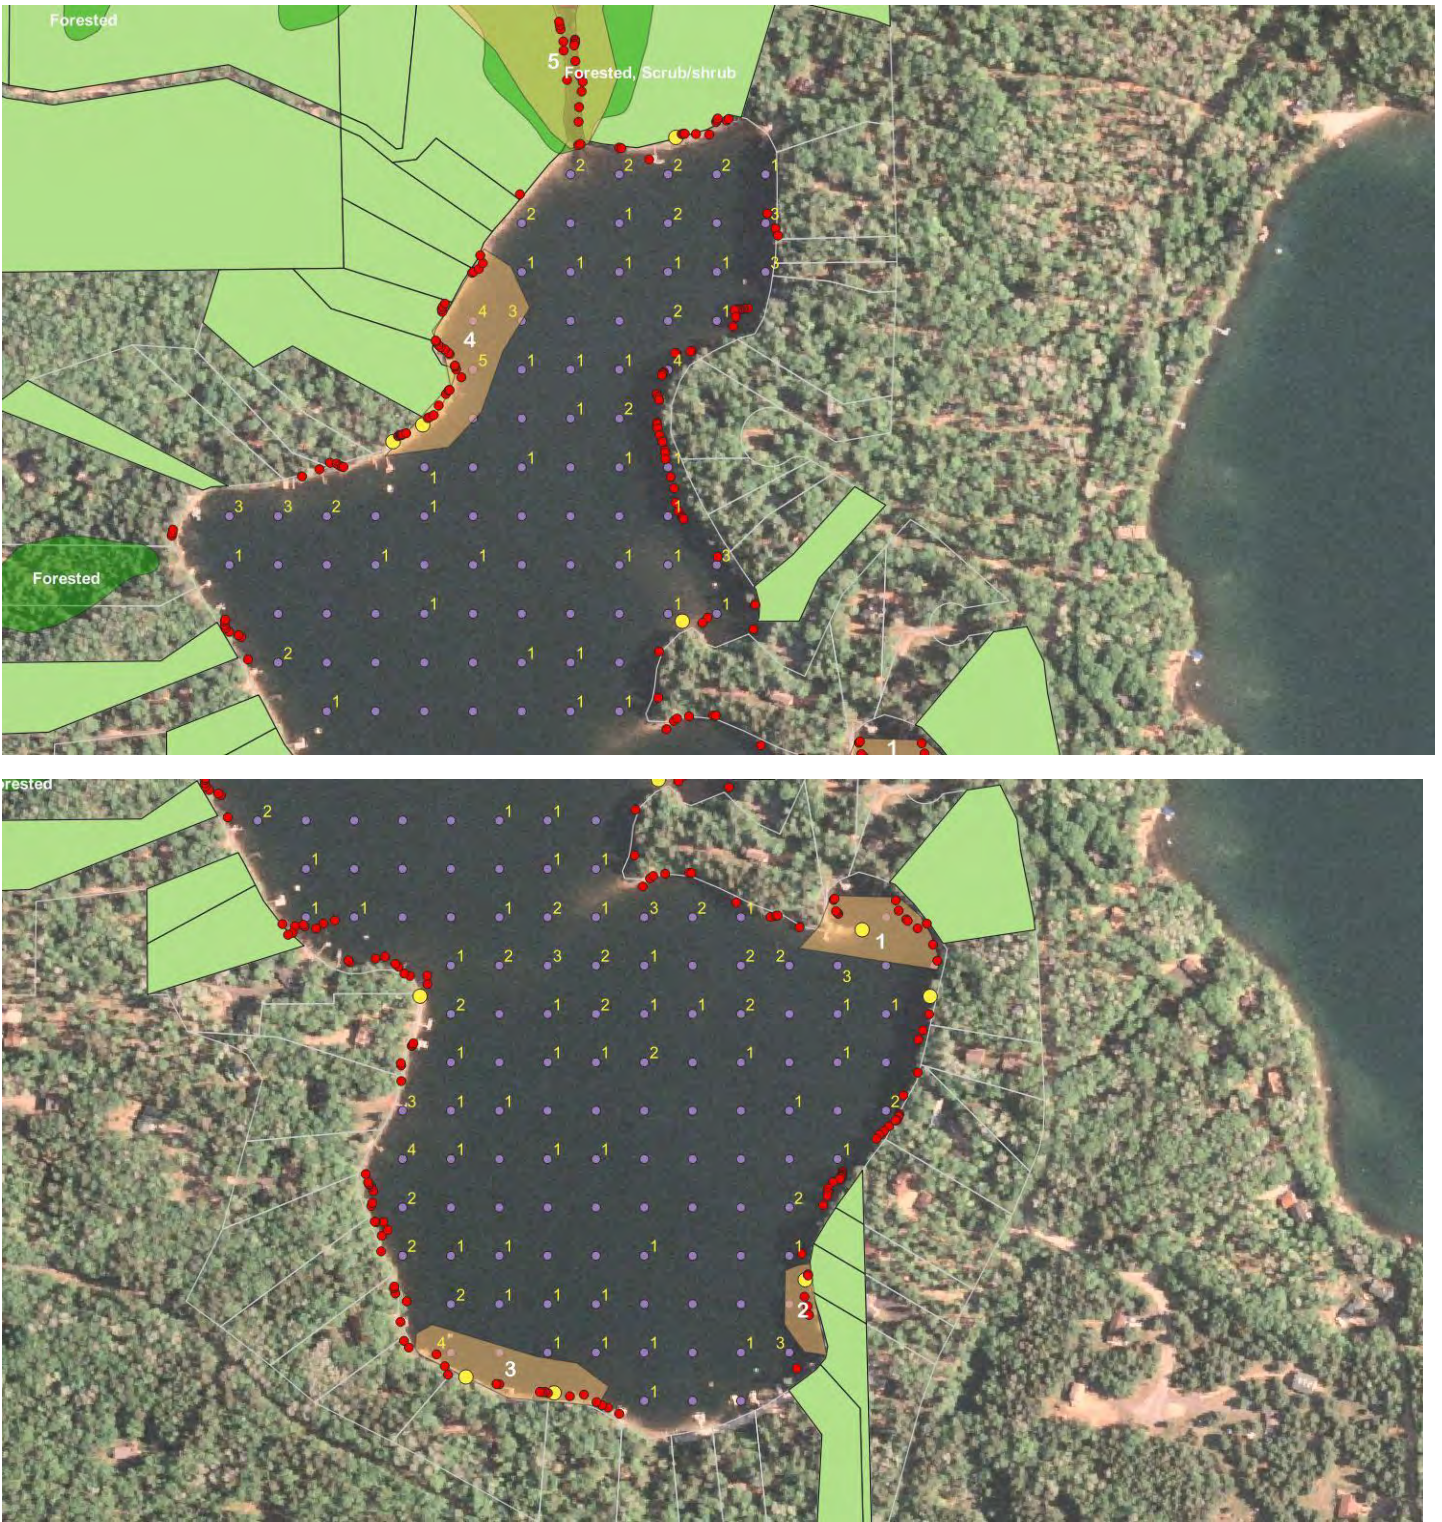
Figure 22. Location of Alma Lake Critical Habitat sites (orange polygons, white numerals) in relation to natural features (red dots=coarse wood; yellow dots=rock/rubble/gravel; purple dots and yellow numerals=2019 Onterra PI Survey results with number of native species per point; light green polygons=natural shoreland; dark green polygons=wetlands).

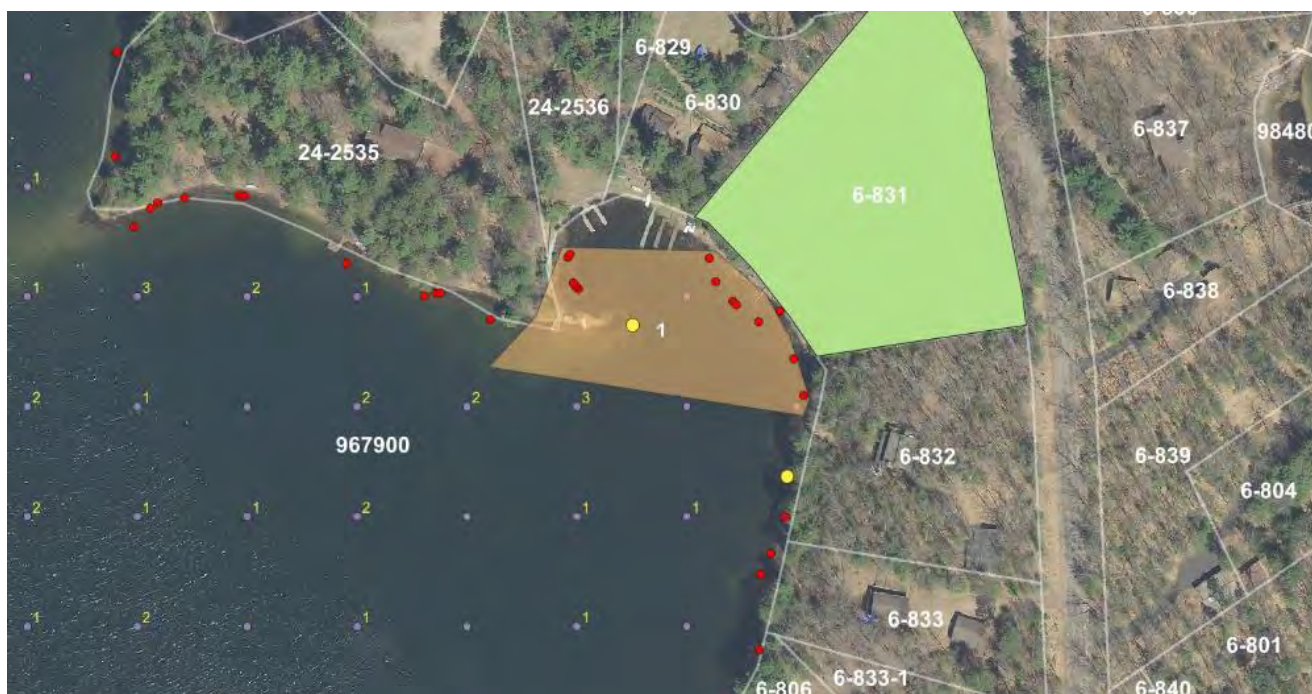
Figure 23. Alma Lake Site 1 - Critical Habitat site (orange polygon, white numeral) in relation to natural features (red dots=coarse wood; yellow dots=rock/rubble/gravel; purple dots and yellow numerals=2019 Onterra PI Survey results with number of native species per point; light green polygons=natural shoreland). Tax parcels white lines, white numerals.

1. No alteration of littoral zone.
2. Maintain existing buffer/riparian zone which is primarily intact.
- 3.. Maintain and do not remove existing coarse wood.

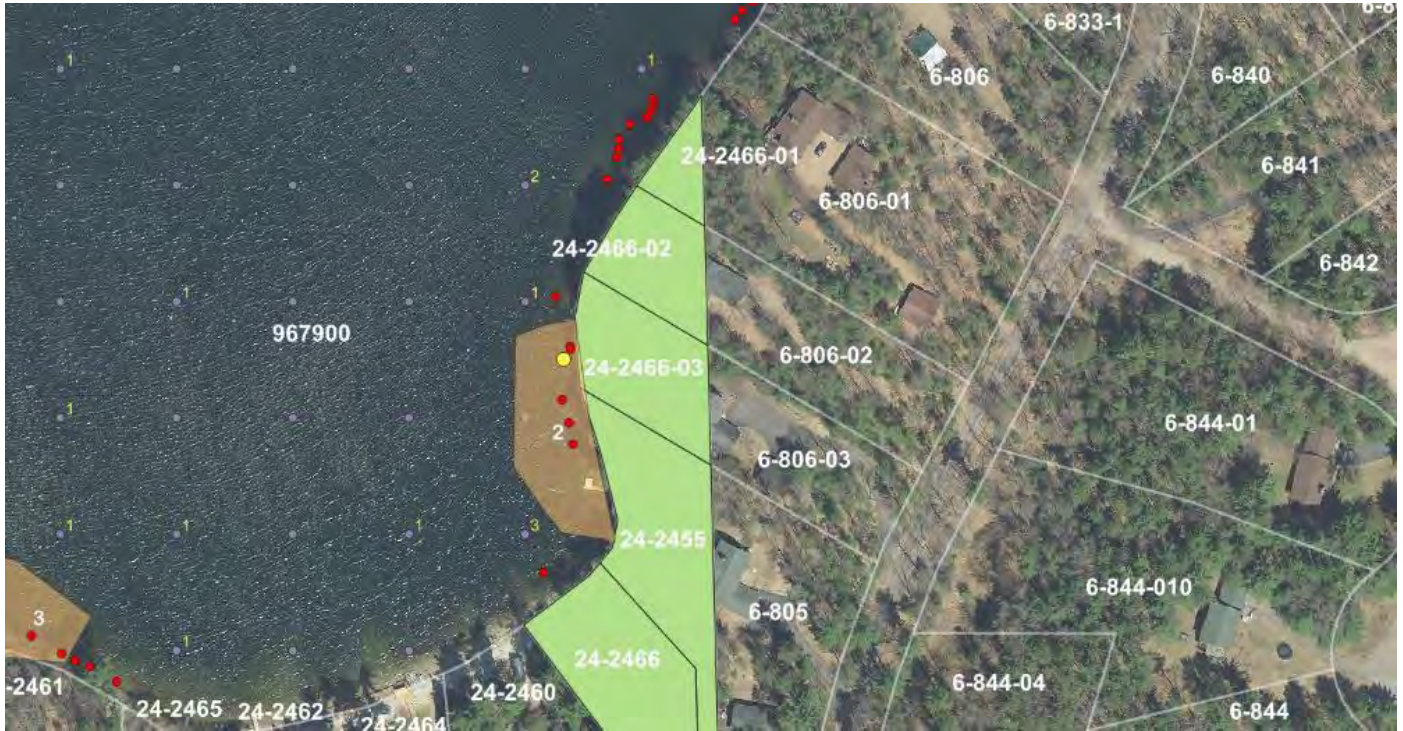
Figure 24. Alma Lake Site 2 - Critical Habitat site (orange polygon, white numeral) in relation to natural features (red dots=coarse wood; yellow dots=rock/rubble/gravel; purple dots and yellow numerals=2019 Onterra PI Survey results with number of native species per point; light green polygons=natural shoreland). Tax parcels white lines, white numerals.

1. No alteration of littoral zone.
2. Maintain existing buffer/riparian zone which is primarily intact.
- 3.. Maintain and do not remove existing coarse wood.

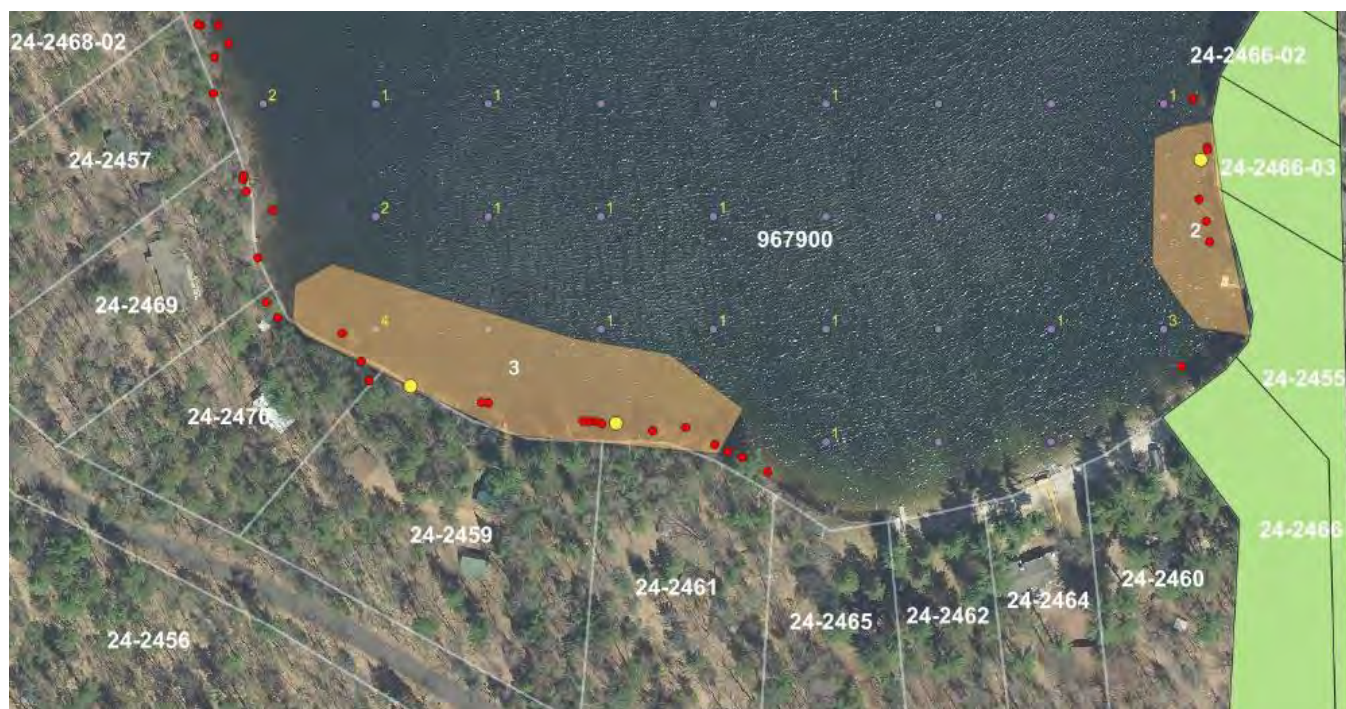
Figure 25. Alma Lake Site 3. Critical Habitat site (orange polygon, white numeral) in relation to natural features (red dots=coarse wood; yellow dots=rock/rubble/gravel; purple dots and yellow numerals=2019 Onterra PI Survey results with number of native species per point; light green polygons=natural shoreland). Tax parcels white lines, white numerals.

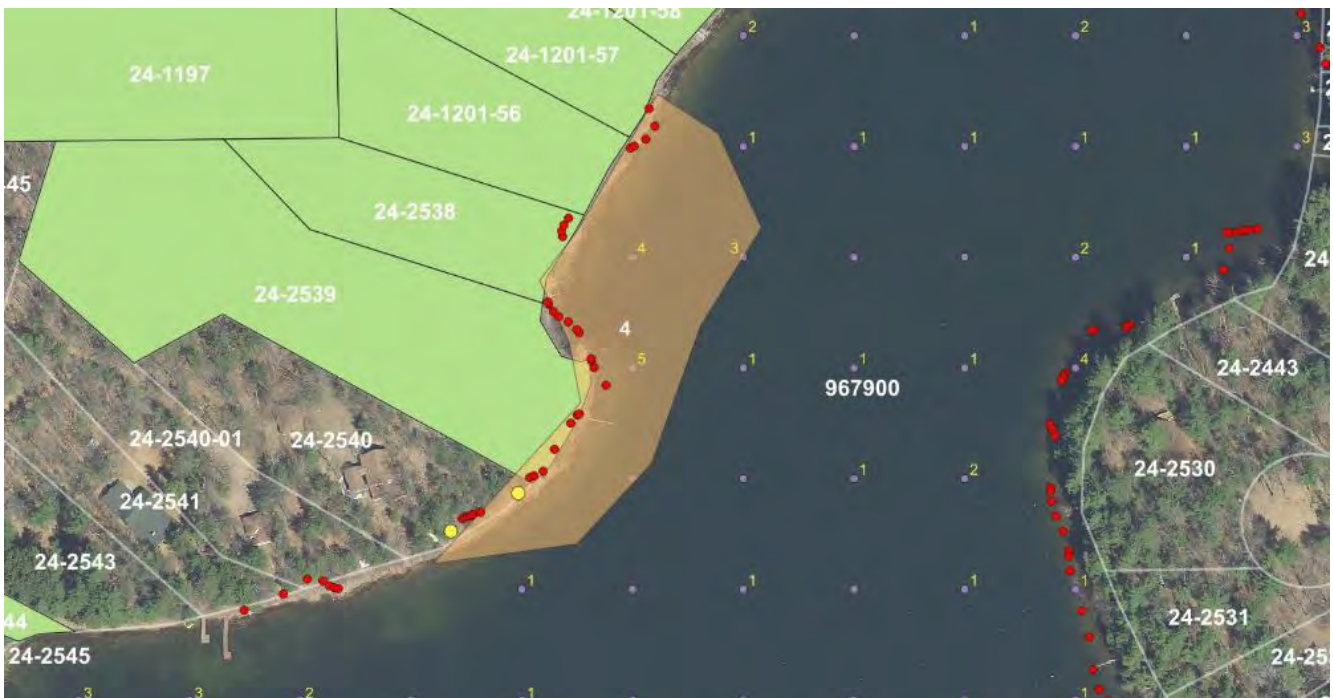
Figure 26. Alma Lake Site 4. Critical Habitat site (orange polygon, white numeral) in relation to natural features (red dots=coarse wood; yellow dots=rock/rubble/gravel; purple dots and yellow numerals=2019 Onterra PI Survey results with number of native species per point; light green polygons=natural shoreland). Tax parcels white lines, white numerals.

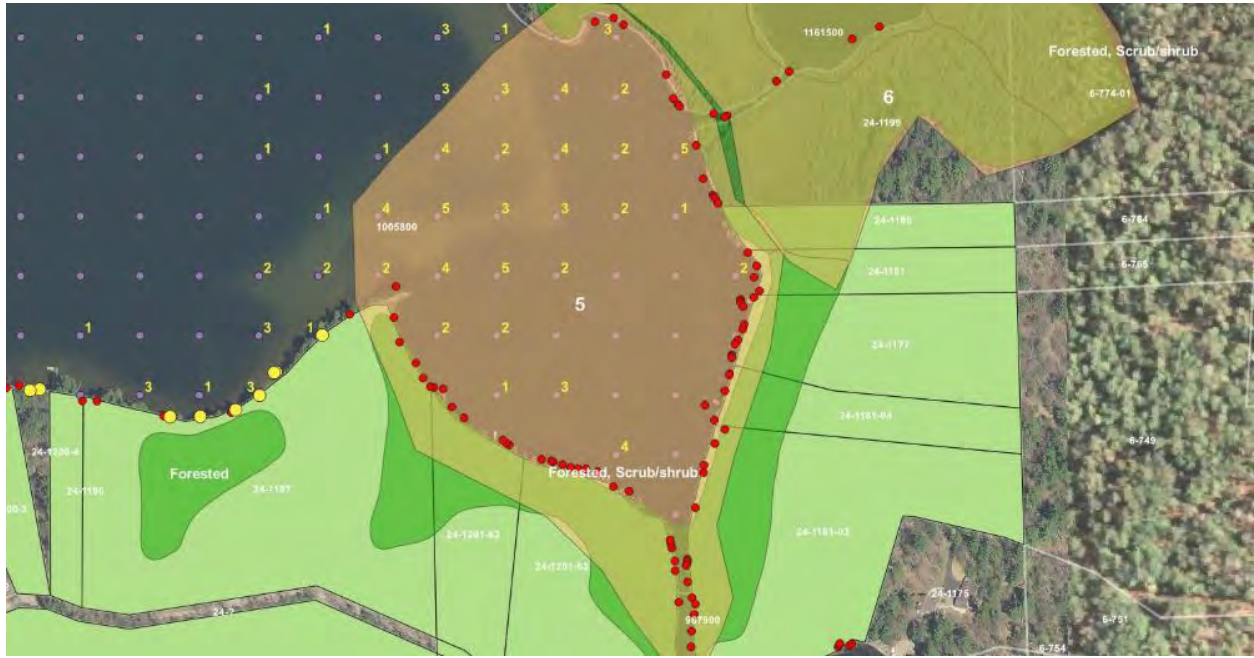
Figure 27. Moon Lake Site 5. Critical Habitat site (orange polygon, white numeral) in relation to natural features (red dots=coarse wood; yellow dots=rock/rubble/gravel; purple dots and yellow numerals=2019 Onterra PI Survey results with number of native species per point; light green polygons=natural shoreland; dark green polygons=wetlands). Tax parcels white lines, white numerals.

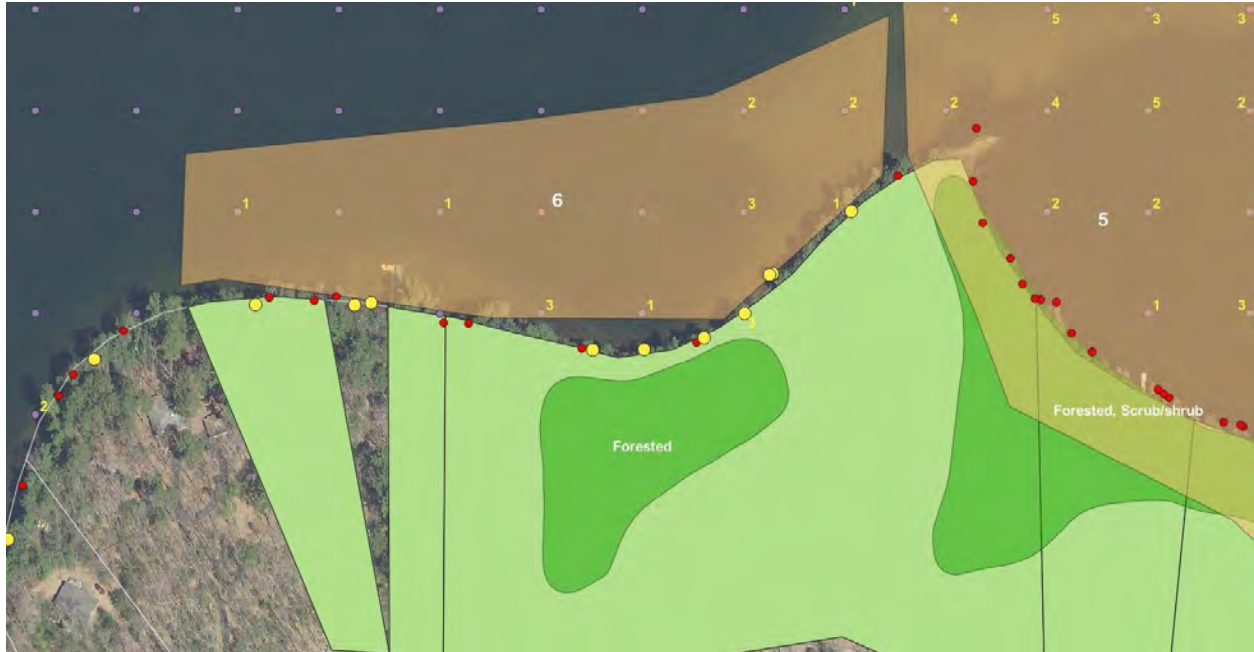
Figure 28. Moon Lake Site 6. Critical Habitat site (orange polygon, white numeral) in relation to natural features (red dots=coarse wood; yellow dots=rock/rubble/gravel; purple dots and yellow numerals=2019 Onterra PI Survey results with number of native species per point; light green polygons=natural shoreland; dark green polygons=wetlands). Tax parcels white lines.

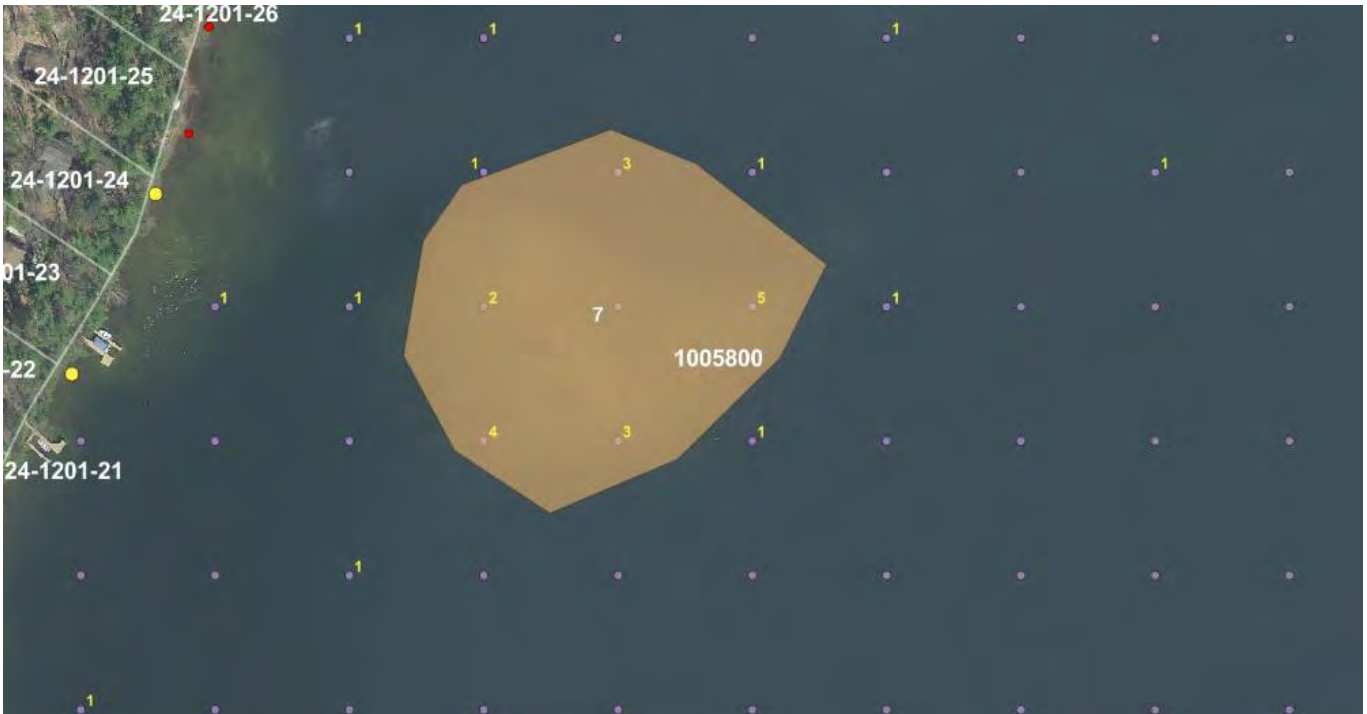
The site includes open water littoral zone habitats (see figure 29). Diverse submergent aquatic vegetation is abundant. The 2019 plant survey showed 2-5 species of plants were found on each rake sample.

Figure 28. Moon Lake Site 7. Critical Habitat site (orange polygon, white numeral) in relation to natural features (red dots=coarse wood; yellow dots=rock/rubble/gravel; purple dots and yellow numerals=2019 Onterra PI Survey results with number of native species per point. Tax parcels white lines, white numerals.

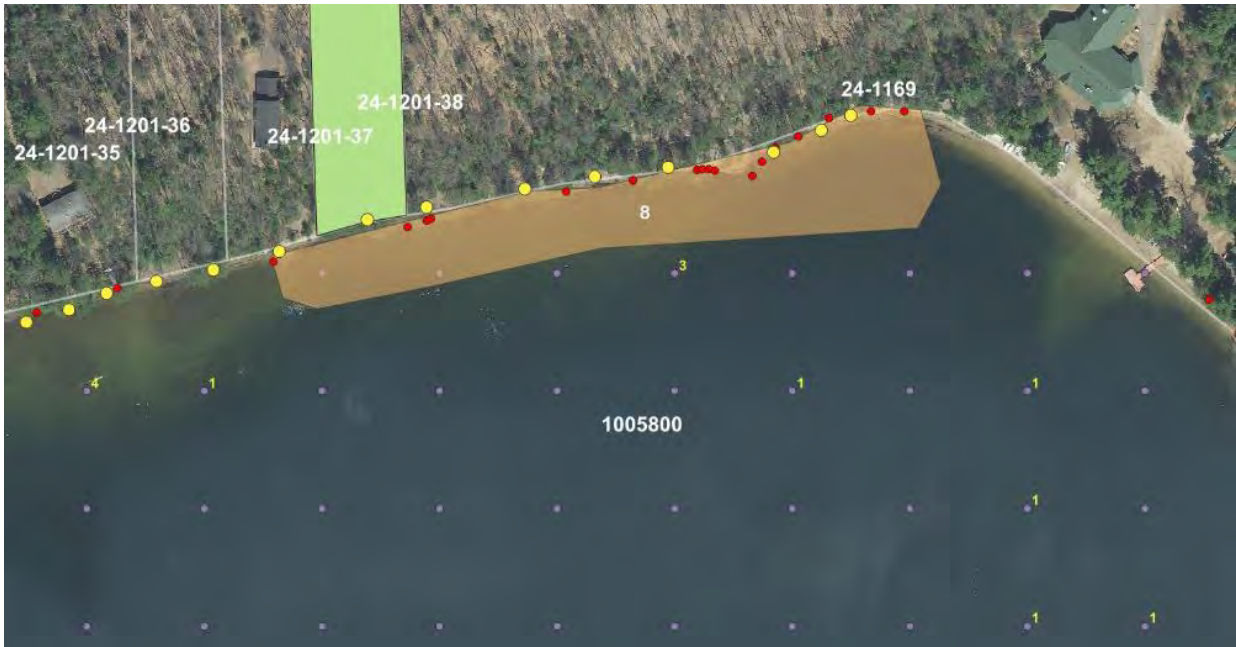
Figure 30. Moon Lake Site 8. Critical Habitat site (orange polygon, white numeral) in relation to natural features (red dots=coarse wood; yellow dots=rock/rubble/gravel; purple dots and yellow numerals=2019 Onterra PI Survey results with number of native species per point; light green polygons=natural shoreland). Tax parcels white lines, white numerals.

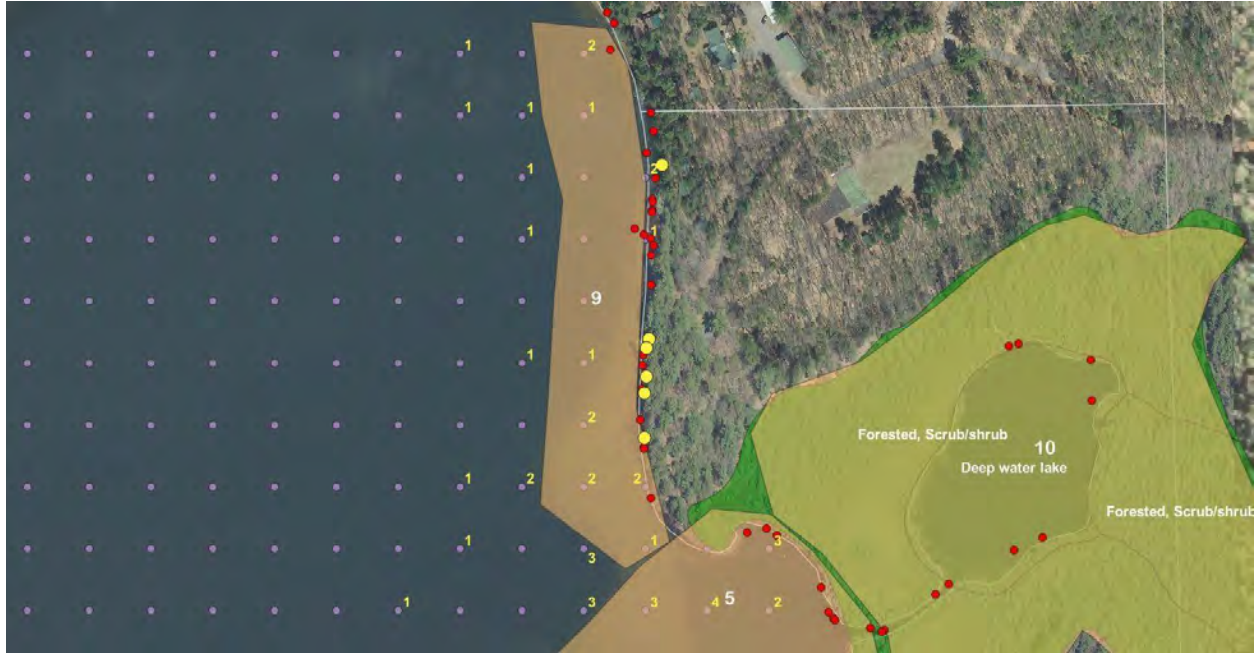
Figure 31. Moon Lake Site 9. Critical Habitat site (orange polygon, white numeral) in relation to natural features (red dots=coarse wood; yellow dots=rock/rubble/gravel; purple dots and yellow numerals=2019 Onterra PI Survey results with number of native species per point; light green polygons=natural shoreland; dark green polygons=wetlands). Tax parcels white lines.

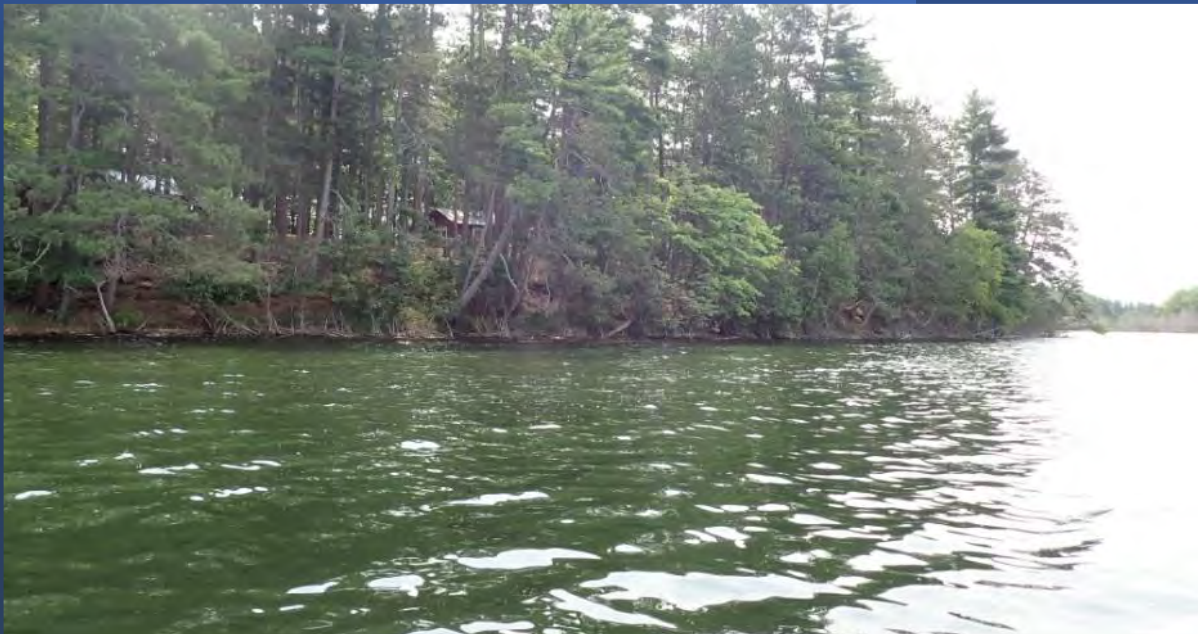
Moon Beach Camp Shoreline Post Restoration Site #9

Erosion problems were corrected through development of rain gardens to capture run-off, as well as use of biodegradable erosion control products to reduce bank erosion. The shoreline was replanted with native trees, shrubs and ground cover that are appropriate for the Moon Lake ecosystem. Tree drops were also added.

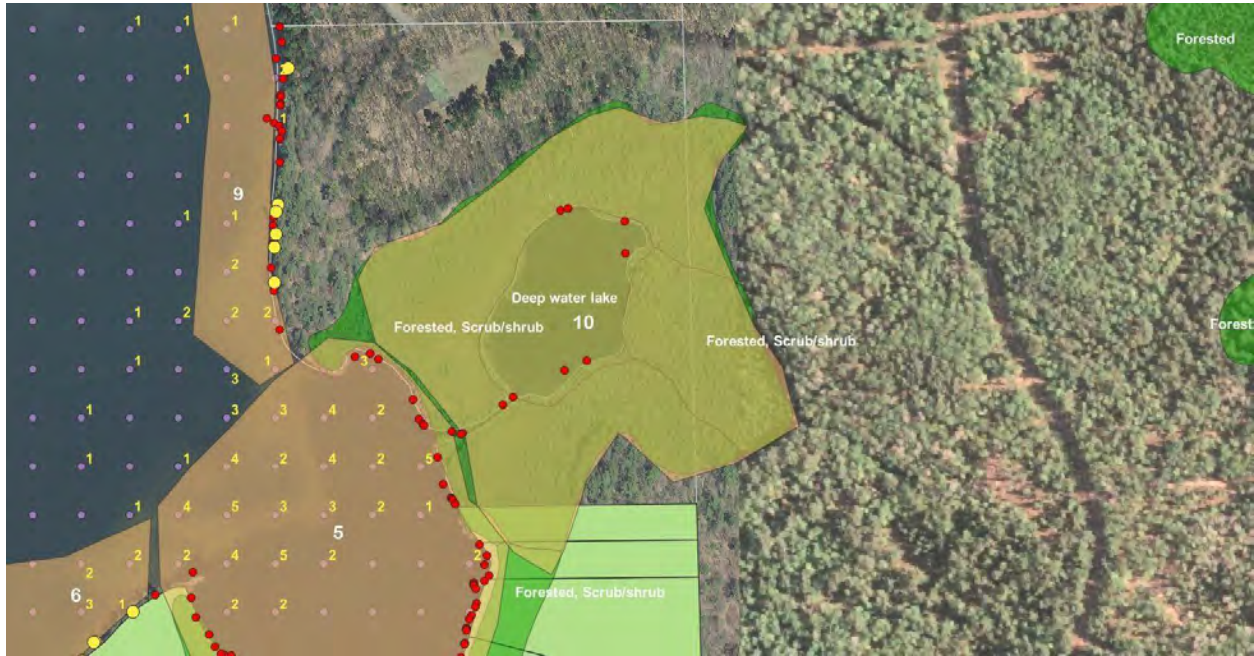
Figure 32. Moon Lake (Engle Lake) Site 10. Critical Habitat site (orange polygon, white numeral) in relation to natural features (red dots=coarse wood; yellow dots=rock/rubble/gravel; purple dots and yellow numerals=2019 Onterra PI Survey results with number of native species per point; light green polygons=natural shoreland; dark green polygons=wetlands). Tax parcels white lines.

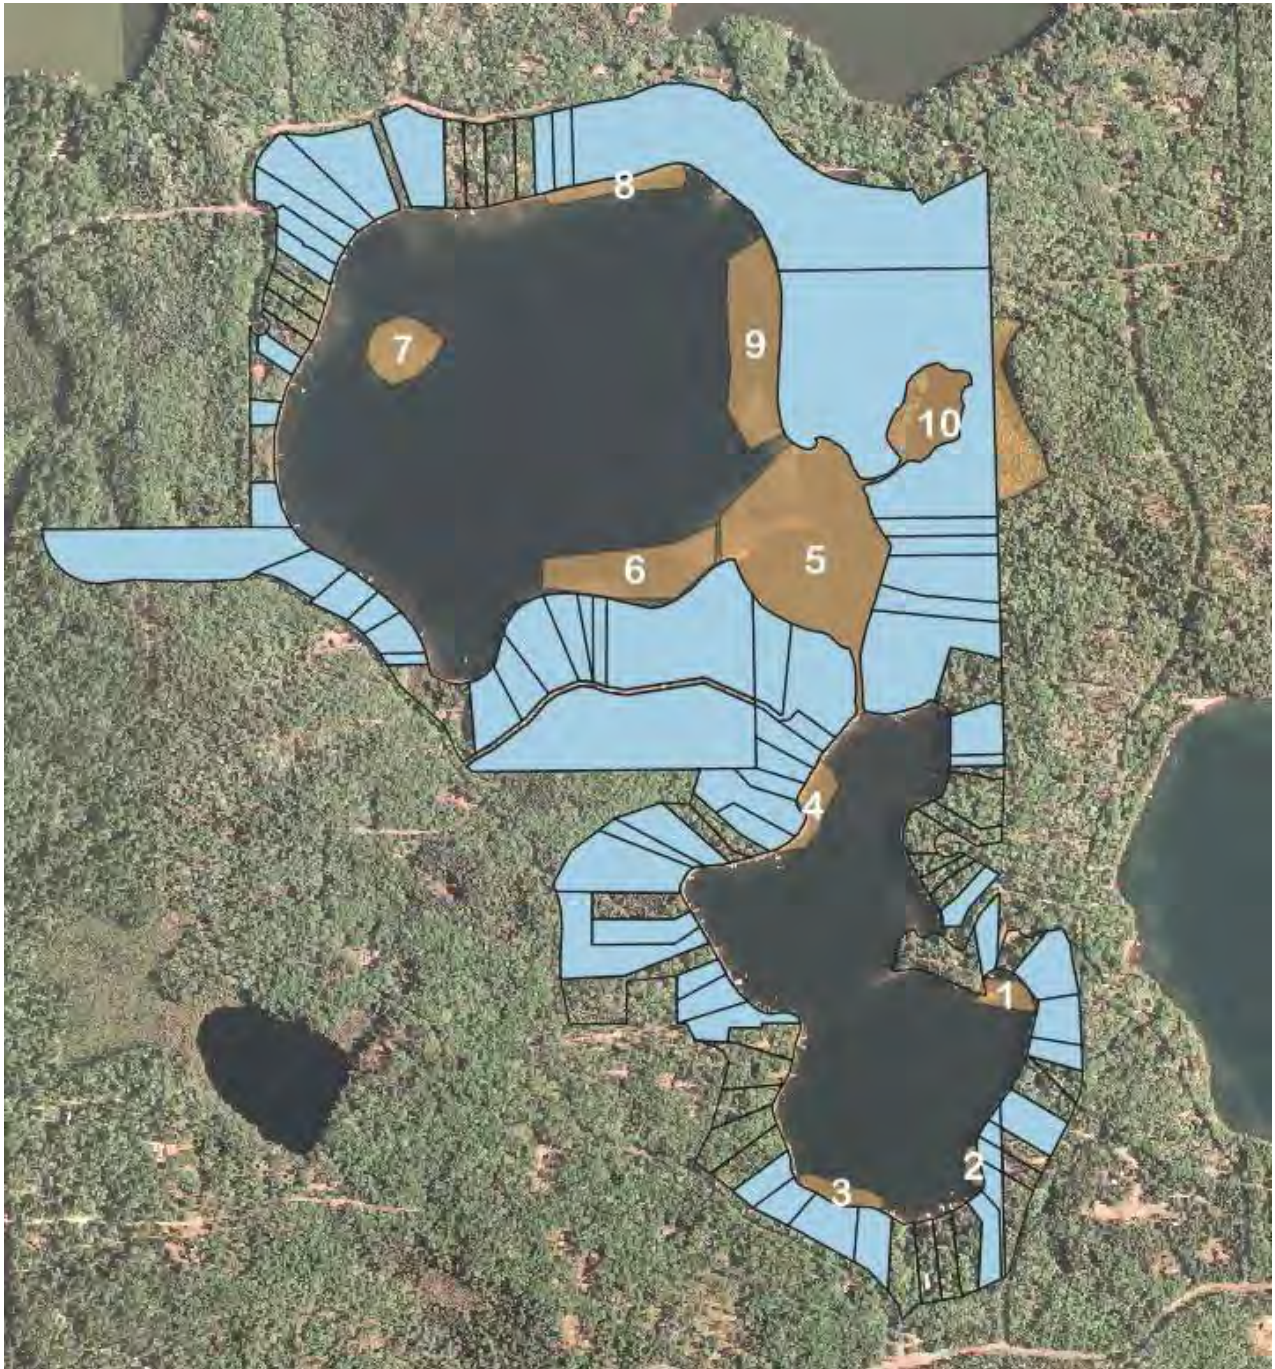
Figure 33. Critical Habitat locations on Alma and Moon Lakes (orange polygons, white numerals) and properties with buffers in good to excellent condition (60-100% native trees, shrubs, and herbaceous cover).

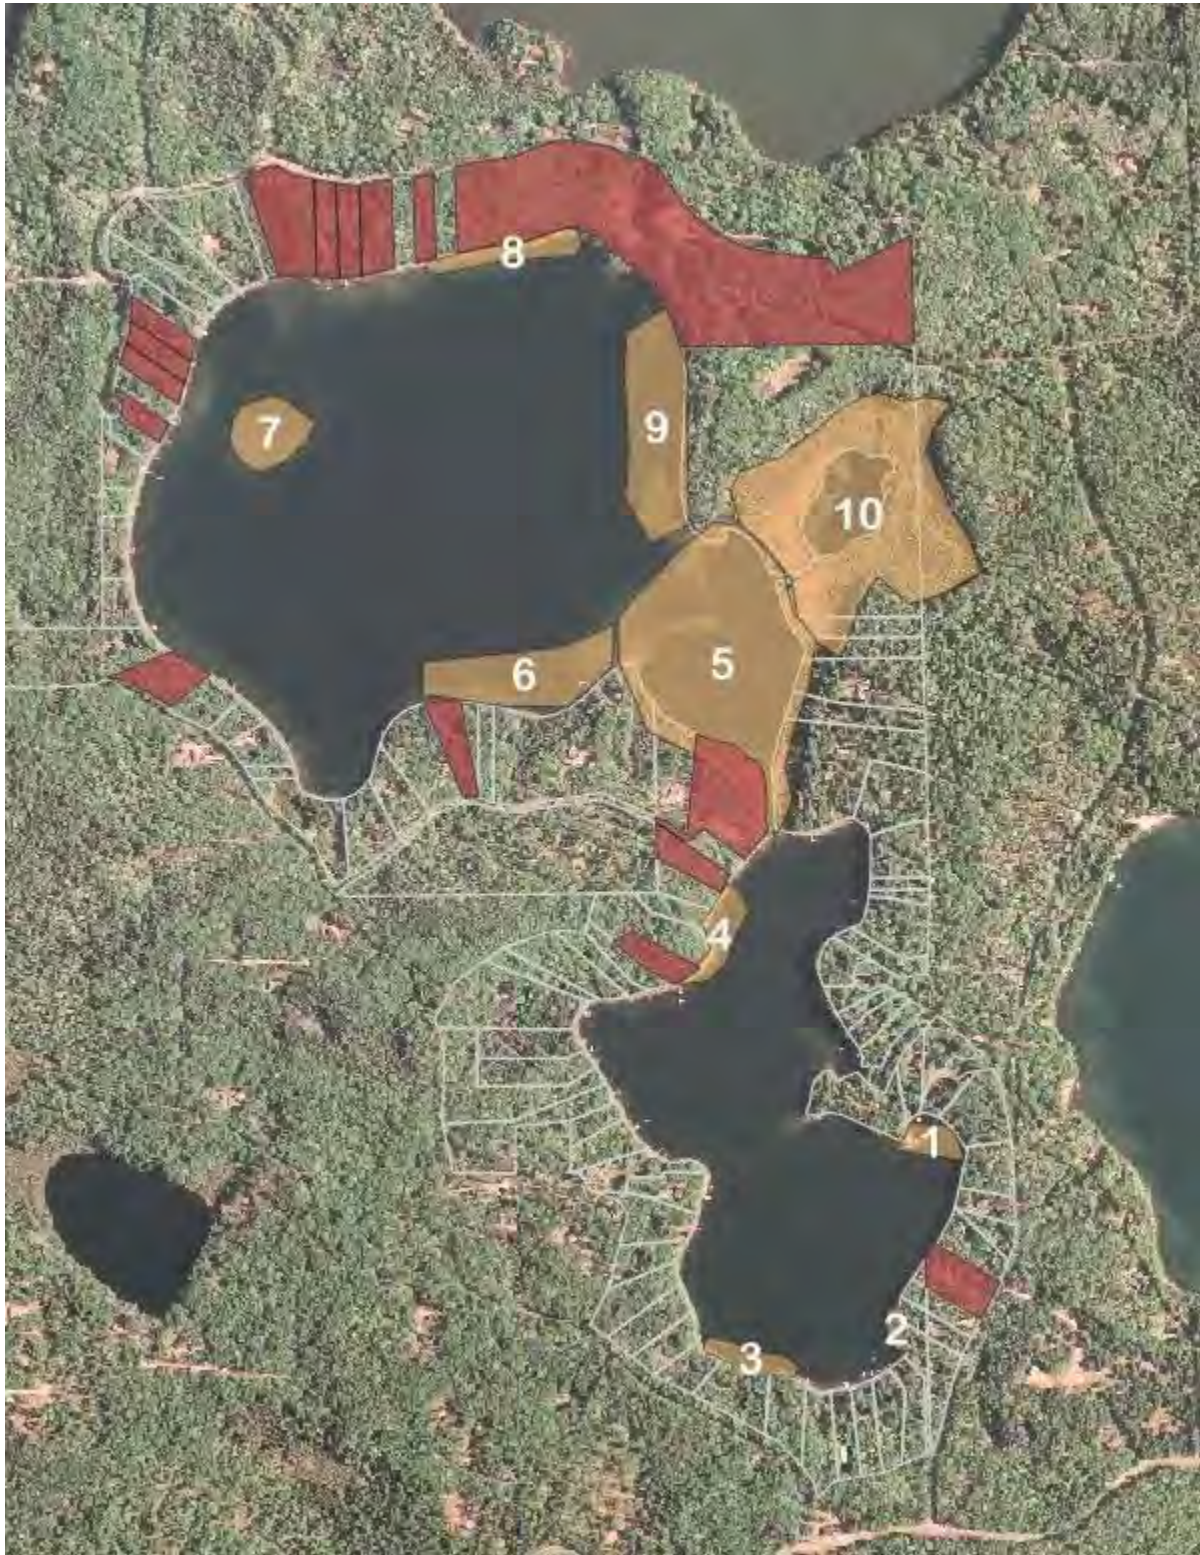
Figure 34. Critical Habitat locations on Alma and Moon Lakes (orange polygons, white numerals) and properties with surface water run-off and/or gully erosion in the shoreland.
