Shoreland Assessments and Critical Habitat Mapping of Alma and Moon Lakes, Vilas County, Wisconsin

Mike Meyer and Jim Kreitlow
NOVA Ecological Services
Boulder Junction, WI 54512
(novaecologicalservies@outlook.com)

June 18, 2024

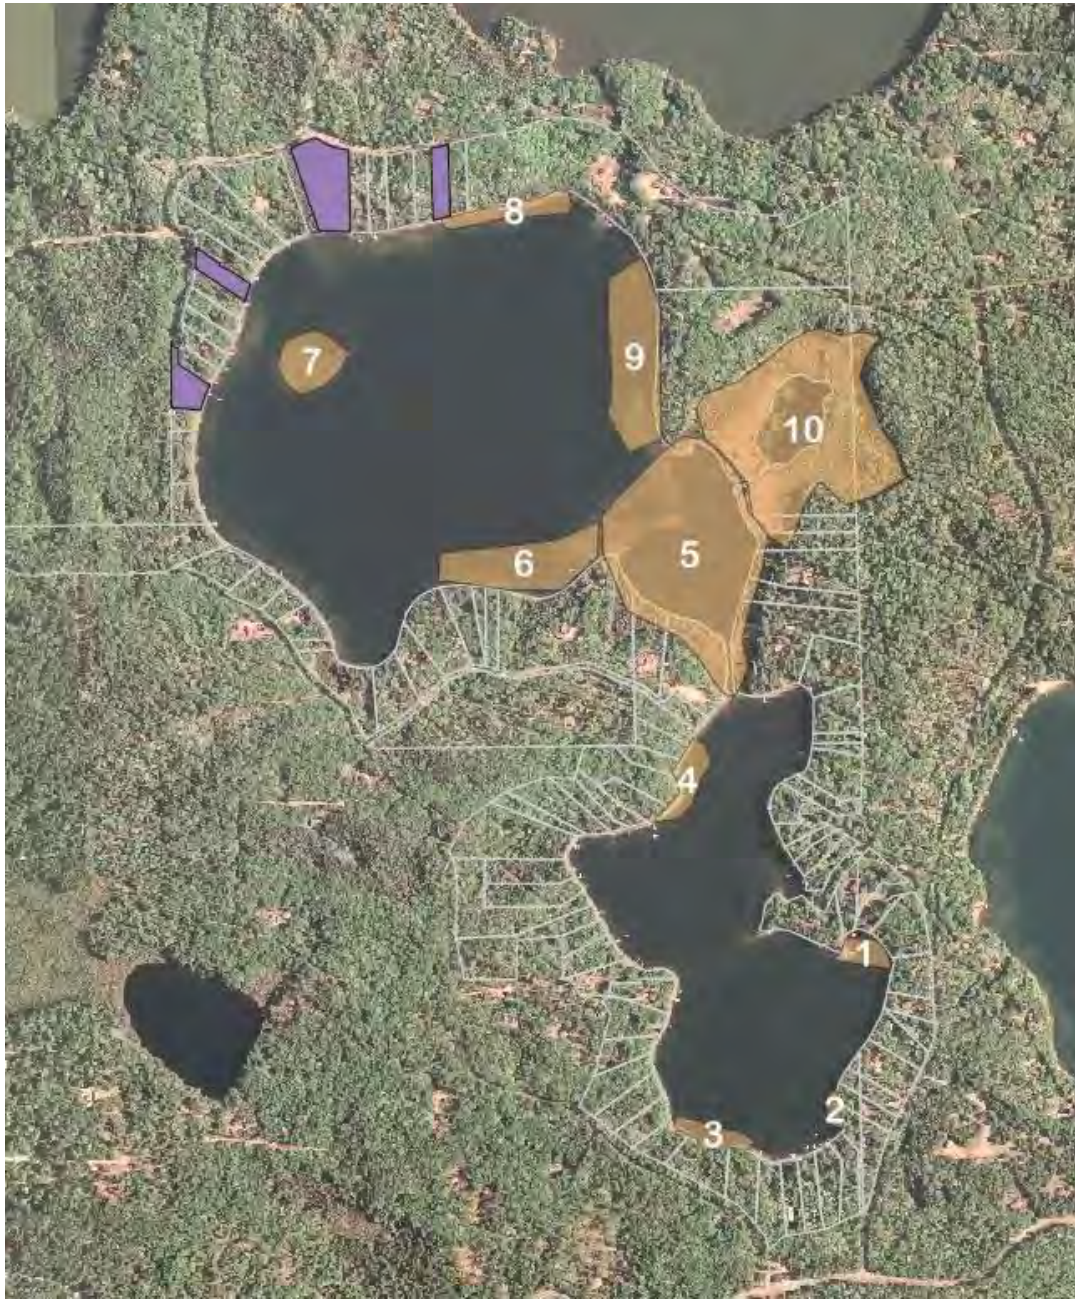
Figure 35. Critical Habitat locations on Alma and Moon Lakes (orange polygons, white numerals) and properties with bank erosion at the shoreland/lake interface.
